# **CONSERVATION AND RESTORATION OF THE CHURCH OF ST GEORGE IN TADZRISI MONASTERY**

## **FINAL REPORT**

TBILISI 2005

Conservation and Restoration of the Church of St George in Tadzrisi Monastery

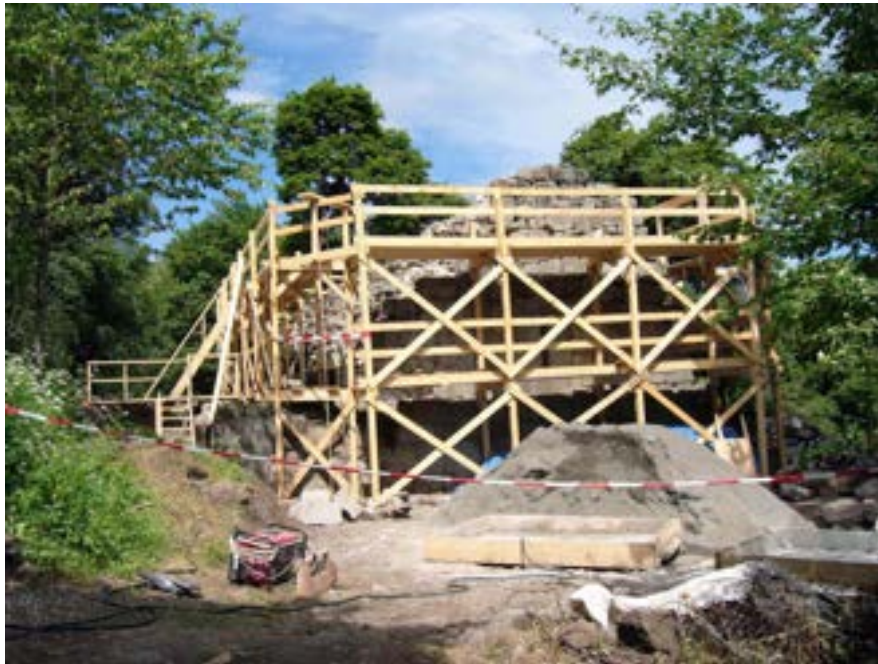
- Construction of the timber scaffolding is completed in accordance with the preliminarily agreed schemes.
- Selection and hewing of suitable stones is in progress.
- After the façade masonry had been numbered, unsteady and weathered stones have been removed from the facades of the church and placed nearby. After removing façade masonry, the walls have been cleaned of vegetation, sedimentary soil, and weathered mortar.
- The team has started the restoration of the masonry on the southern façade. Previously removed and numbered stones are used in this work.

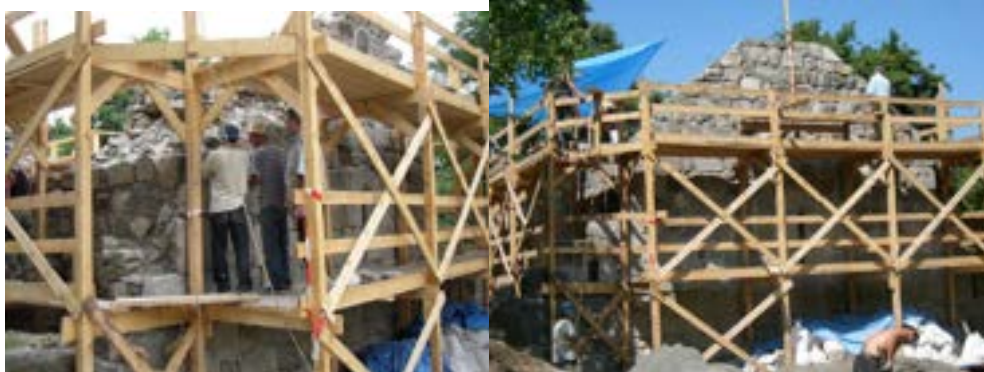
Restoration of the facing masonry on the northern wall, south-western and north-eastern corners is going on.

Filling of the joints with lime mortar on the newly restored masonry in the north-eastern part of the church has been started.

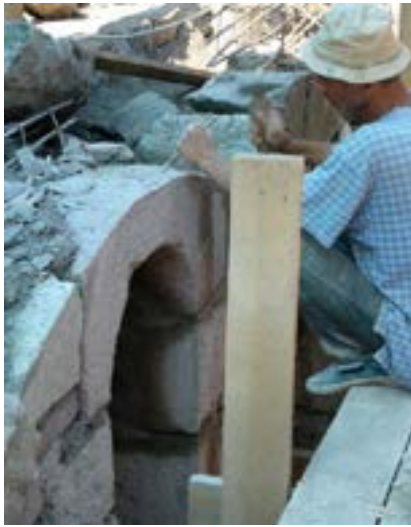
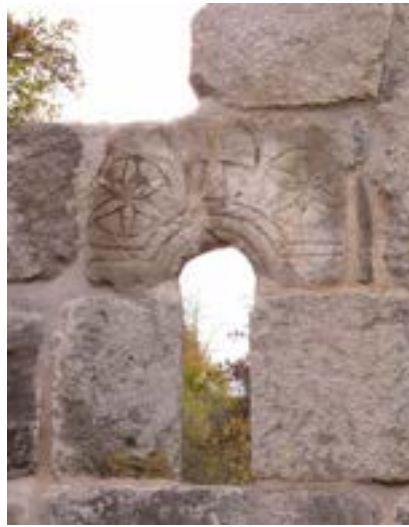
- Restoration of the facing masonry of the southern façade of the nave is in progress. Two window lintels have been installed on the southern wall. One of them is an old lintel stone found during cleaning works, and another has been made in the likeness of the old one

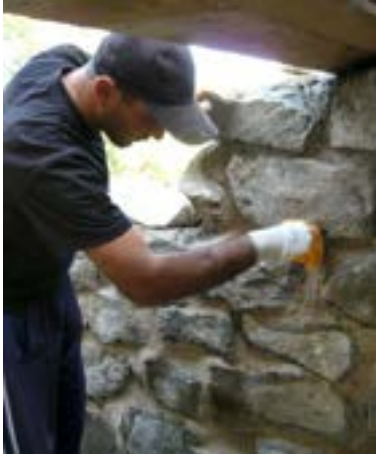
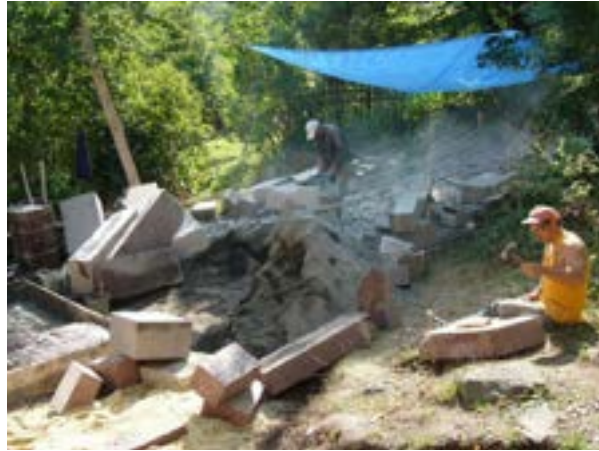
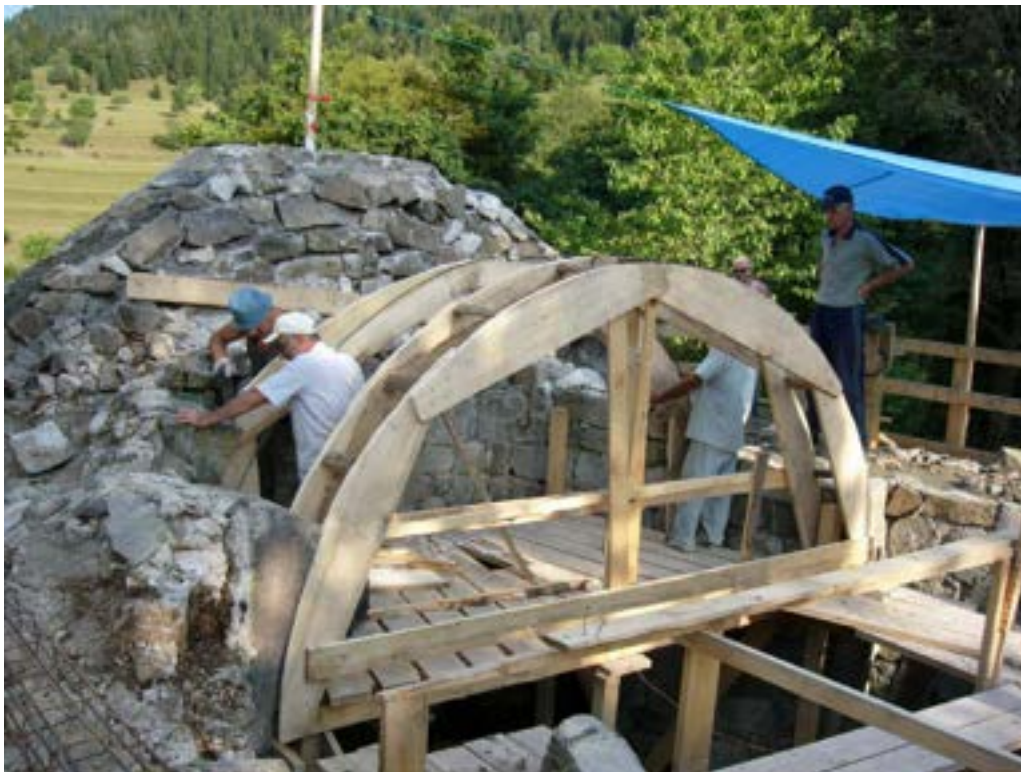
- Restoration of gables has been completed.
- The interior of the church has been cleaned of debris piled up during construction work (old weathered plaster, fallen stones, mortar, soil, etc).
- Two pilasters of the longitudinal walls have been restored with smoothly hewn ashlar.
- A wooden formwork was erected for the conch (semidome) of the apse and its facing arch. The formwork consists of semicircular timber bows and is veneered.
- New stones for the facing arch of the conch have been hewn manually.
- Restoration of the cornice was going on using newly hewn oblong reddish stones.
- Restoration of the conch of the apse and its facing arch has been started.

- Filling of joints between stones with special lime mortar has been completed on the lower parts of façades.

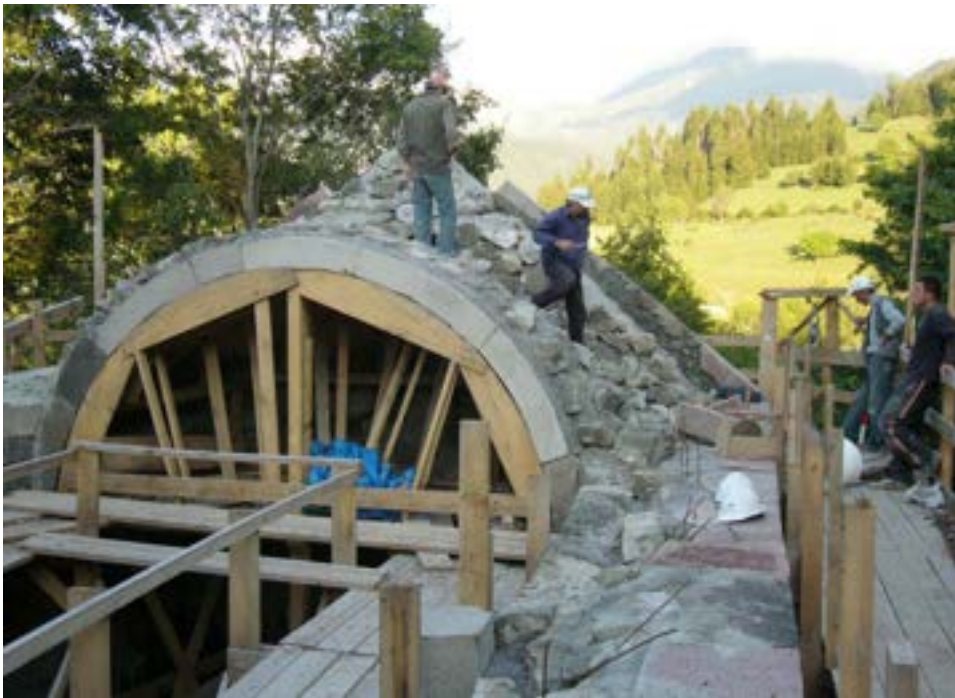
- Restoration works on the conch (semidome) of the apse and its facing arch have been completed. The arch has been rebuilt with new smoothly finished stones, also using two old stones found during cleaning works in the interior of the church. The conch has been restored on the formwork, in two courses of stones. The conch and the arch are linked with each other by means of metal holdfasts and anchors.

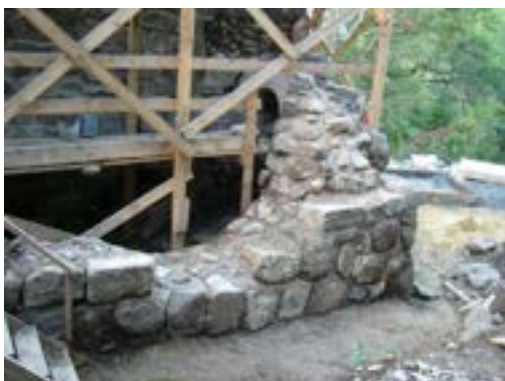
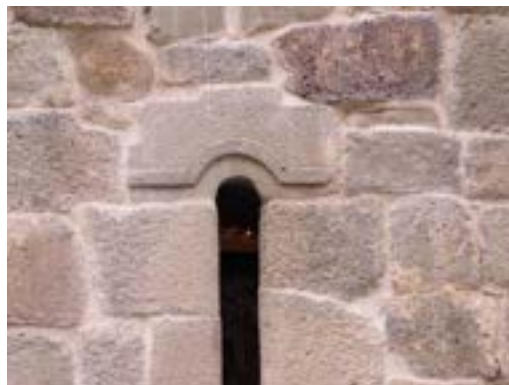
- The cornice of the southern wall has been restored with newly hewn oblong reddish stones, which had previously been cut in stone-cutting workshop.
- Two springing stones of the collapsed supporting arch of vaulting on both its sides have been restored. They are rested on the recently rebuilt pilasters of longitudinal walls.
- Conservation works on the southern annex of the church were in progress. Specifically, its eastern wall and the eastern part of the south wall have been processed and conservation layer has been made. Conservation of the western wall and the western portion of the southern wall of the annex has been started.
- Filling of joints between stones on facades with special lime mortar has been completed.
- The final stage of the cleaning works of the area has been started.

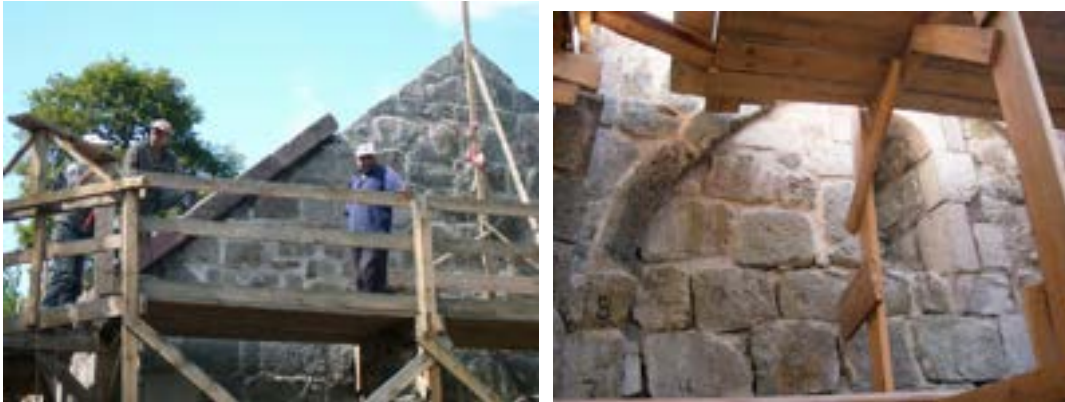
- The cornice of the eastern gable has been restored with newly hewn oblong reddish stones, which previously had been cut in stone-cutting workshop. The old authentic stones, which had been cleaned from old plaster and moss, have been used in the restoration of the gable as well.

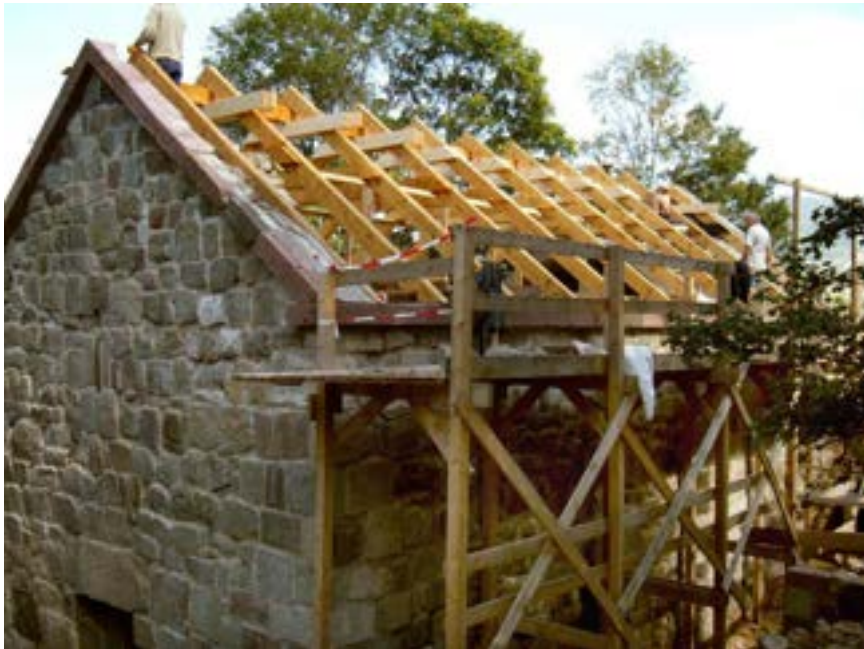
- The team has completed erecting timber frame of the roofing. Side tie-beams / deck stringers have been installed above cornices and tied with the belt of the church by means of special cramp-irons. Trusses have been made and linked with each other by means of bottom and top chords. The roofing frame is made of planed timber covered with protective light transparent varnish.

- In the southern annex, the final stage of the cleaning works has been completed. The ground level has been lowered and prepared for paving.
- The team has completed the final stage of the cleaning works in the area to the south of the church.

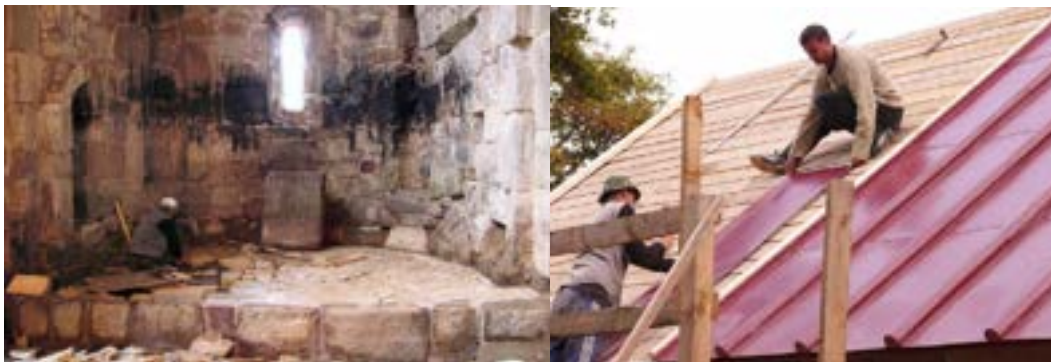
- The team started making pavement of stone shale pieces in the apse and the southern annex.
- On September 25, tinmen began the roofing works using tin plates. By the end of this working period, the roof has been made on the southern slope.

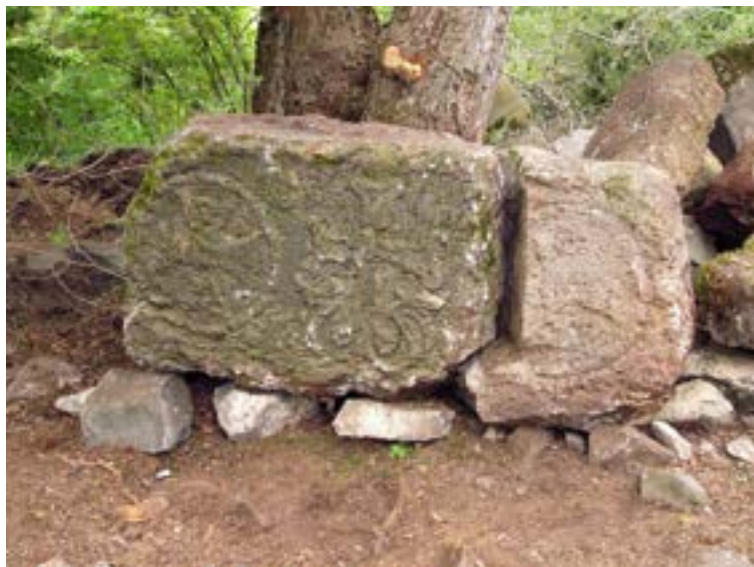
Among the revealed materials, a huge architrave stone merits particular attention. Part of the stone was lying partly covered with sedimentary soil to the west of the church, close to the St Mary's Chapel. During cleaning works, another part was found nearby, in the roots of a big tree. Thus, the whole architrave has been reunited. It has the carved image of three crosses on its front side – a flourishing cross in the middle and equilateral crosses inscribed into circles (so-called Bolnisi Cross) on each side.

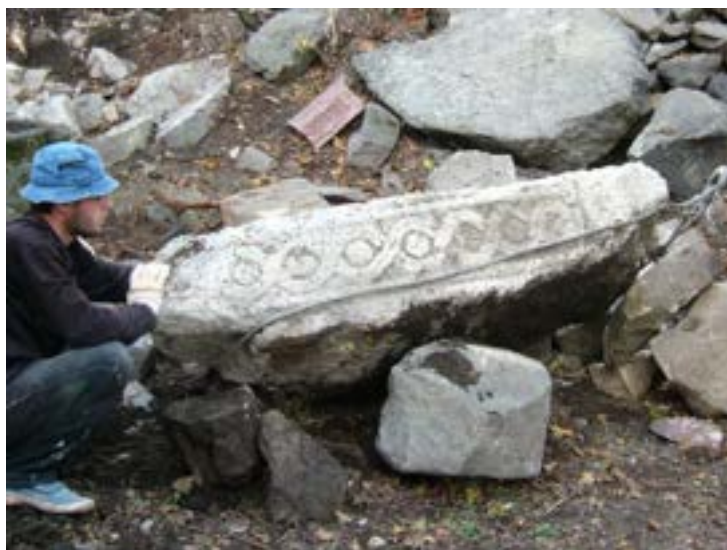
One more architrave stone has been found in the newly cleaned southern annex. Its front side is adorned with the frieze of carved 8-shape interlaced bands. Lower corners of the stone are cut out rectangularly that indicates its function – it was placed above the door and supported by jambs. Resembling ornamental friezes are recorded in the churches of Kumurdo (964) and Zegani / Zaki (mid-tenth century).

After cleaning the southern annex and removing later masonry from its southern door, the exact width of this door has been defined. The size of the architrave and the place of find suggest that it belonged to that very door.

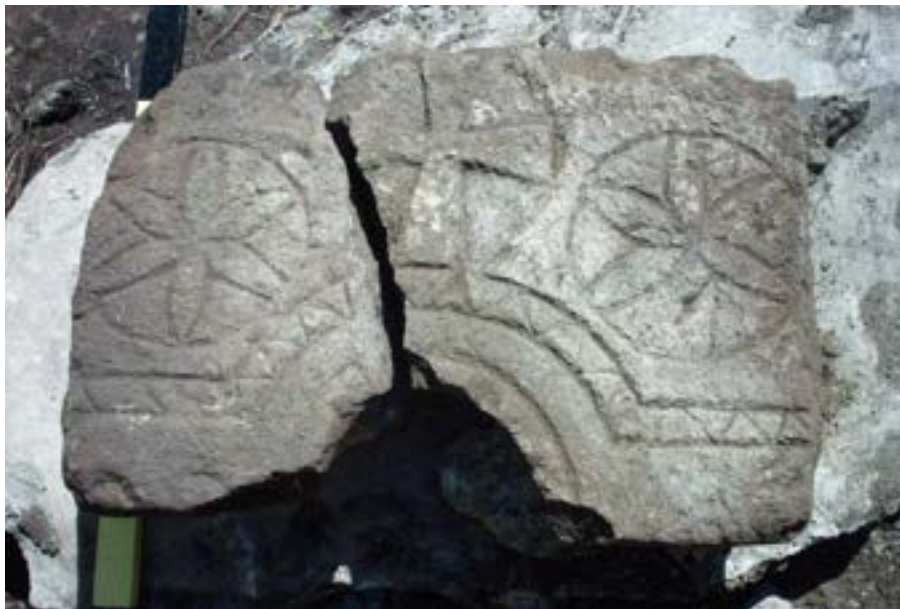
The window lintels are one more significant discovery made during cleaning work. One of them has an adornment in the form of a brow, a cross inscribed in a circle, and two rosettes on the both sides of the cross. The decoration recalls that of the afore-mentioned architrave and of the western window of the church. Undoubtedly, the lintel was a part of the church decoration. It has parallels in many tenth-century Georgian churches, such as Vani in Javakheti, Disevi, Kobeti, Kvabiskhevi, Prisi, etc. Its complicated versions can be seen above the western window of Satkhe church and southern window of Armazi church. The fact that the lintel has been found close to the south-eastern corner of the church naturally suggests that it belonged to the eastern window of the southern annex. In the restoration process, it was adjusted to the window and thus successfully reused. The lintel found near the north-eastern corner of the church with double-brow decoration undoubtedly belonged to the eastern window of the northern annex. During the restoration, it has also been put above the window. As for the eastern window of the nave, which has survived in its initial place, it has a plain decoration in the form of a brow.

Thus, among the adornments of the three eastern windows of the church, that of the southern annex is the richest. It might be caused by the special significance of the annex, determined by the presence of the crypt in its apse.

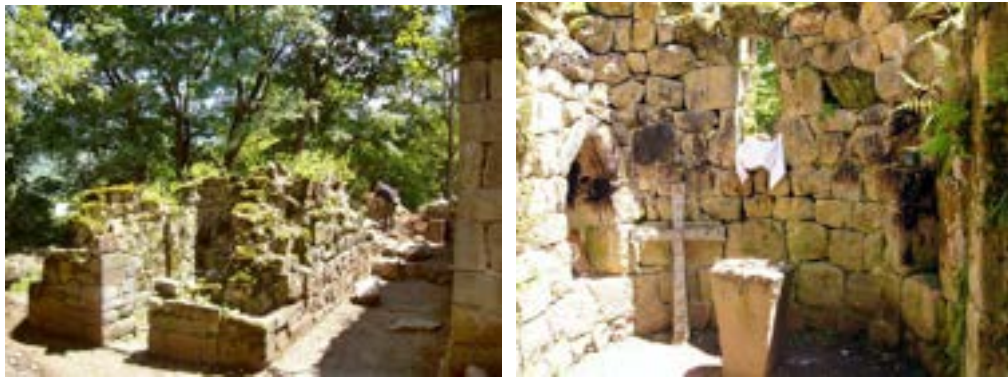
At the time of renewal, the chapel of St Mary, a small single-nave structure, was constructed to the northern annex of the St George’s church. Cleaning work made clear that the southern wall of the chapel is built over the northern wall of the northern annex. The apse of the chapel repeats in a smaller scale the apse of the church. Builders of the chapels reused fallen cornice stones of the church. All these confirm the fact that the chapel was erected after the church had collapsed. It may be dated from the fifteenth century. Presumably, it is contemporary to the church renewal.

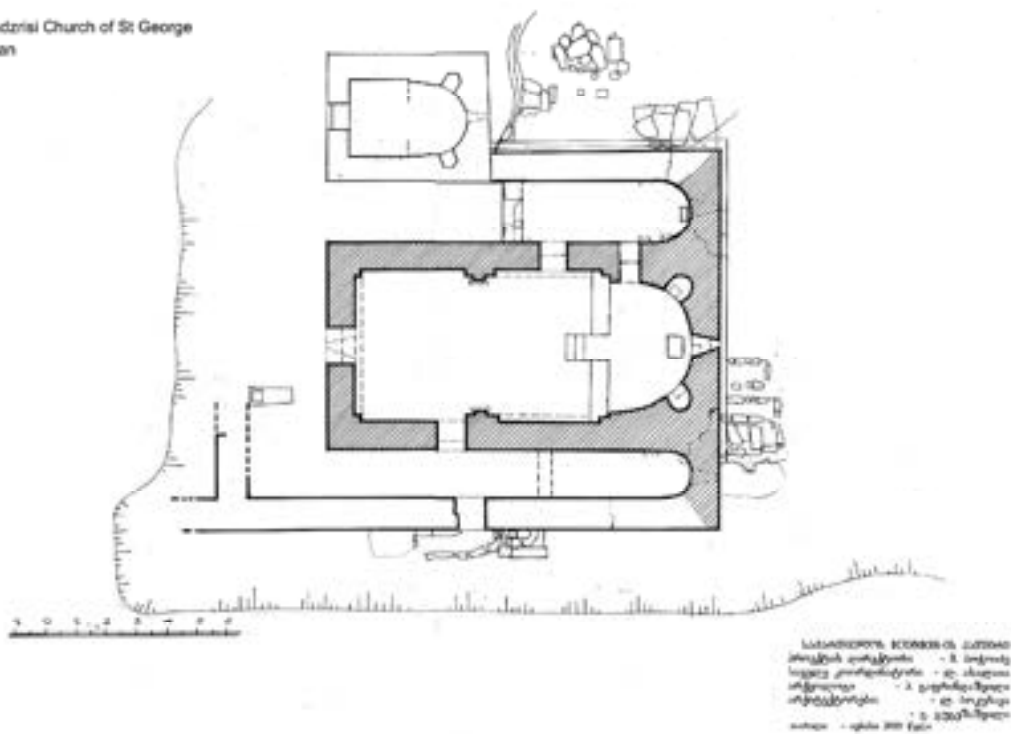
Tadrisi Church of St George  
Plan

St. George's Church is a large tripartite basilica (17 x 13 m), both from inside and outside faced with light yellowish-grey sandstone blocks, which are bound in more or less regular courses with a frequent use of filling. The central nave is wider and higher than southern and northern annexes. It has a sanctuary in the form of an apse in its east side. Two high and deep niches flank a window in the middle of the apse. They grow narrow and have arched tops. An altar stone in the centre of the sanctuary stands very close to the semicircular wall of the apse.

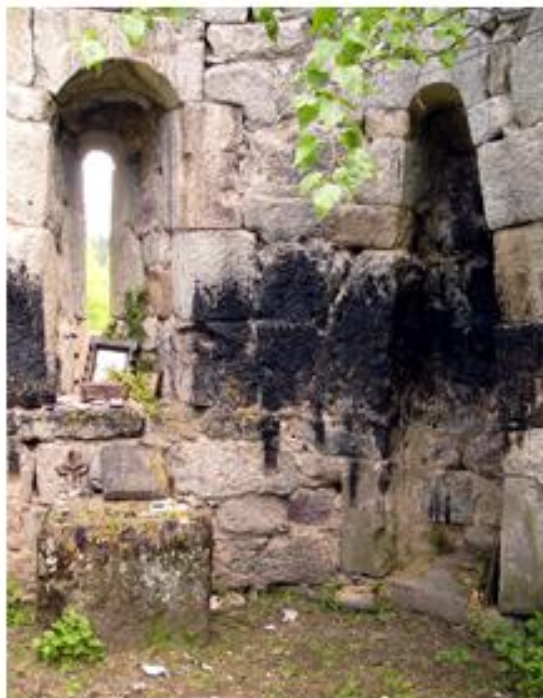
**The fragment of apse.**

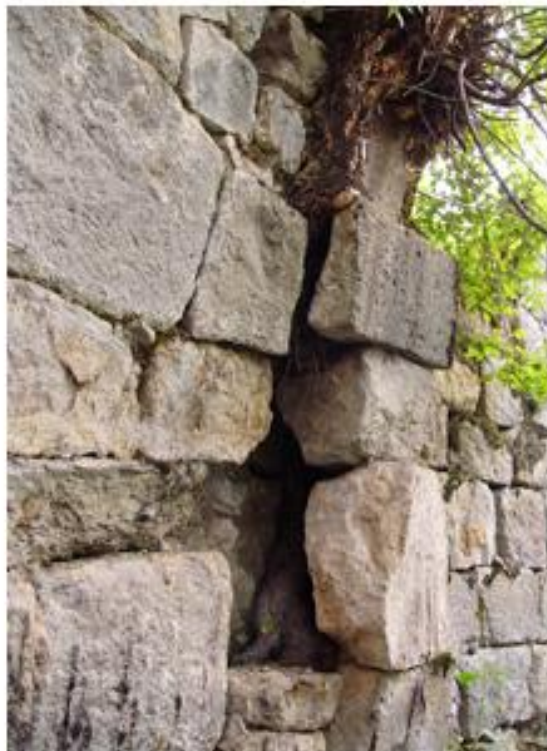
**The S corner of the apse .**

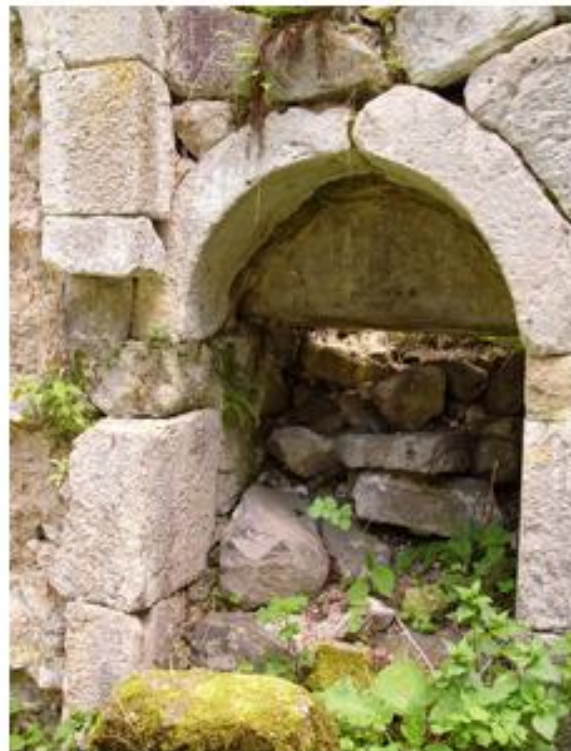
**The door on the S wall.**

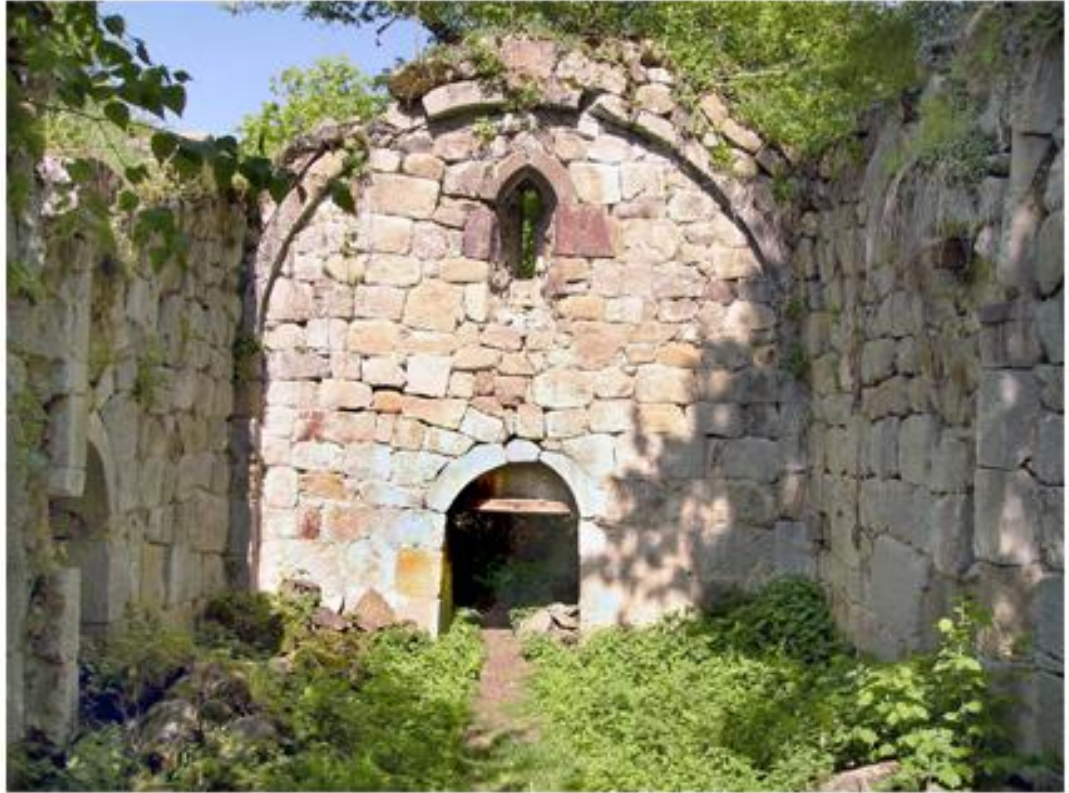
interior, view to W.

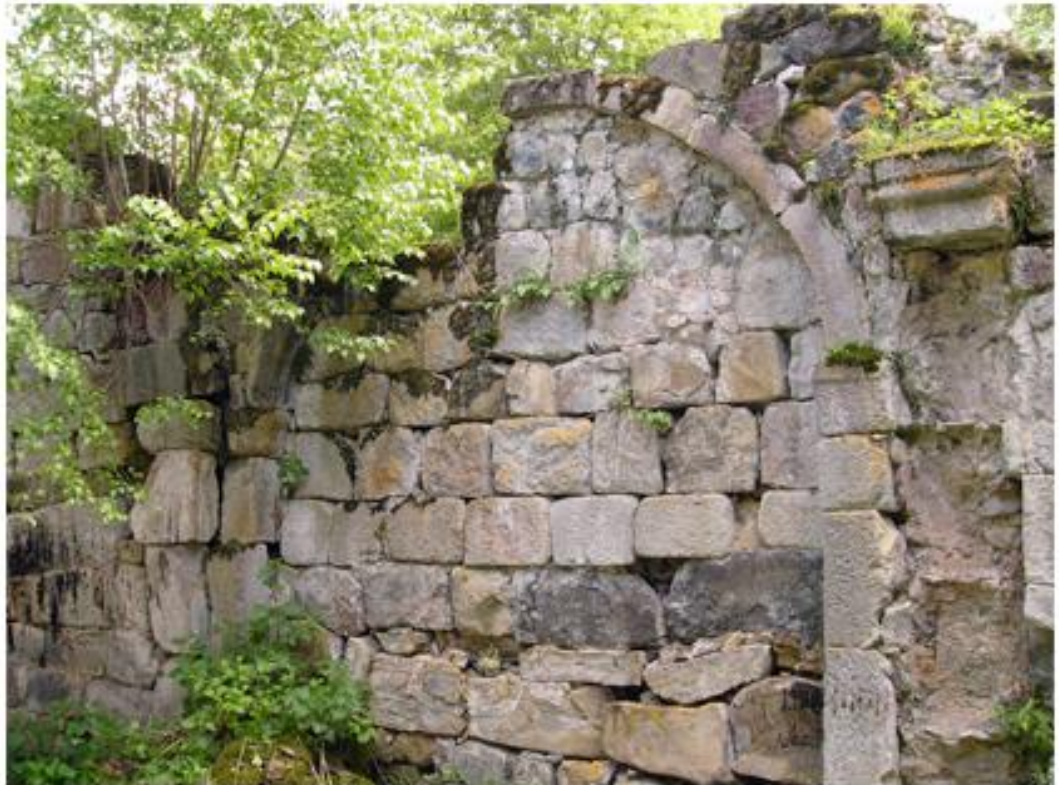
Interior, the fragment of the S wall.

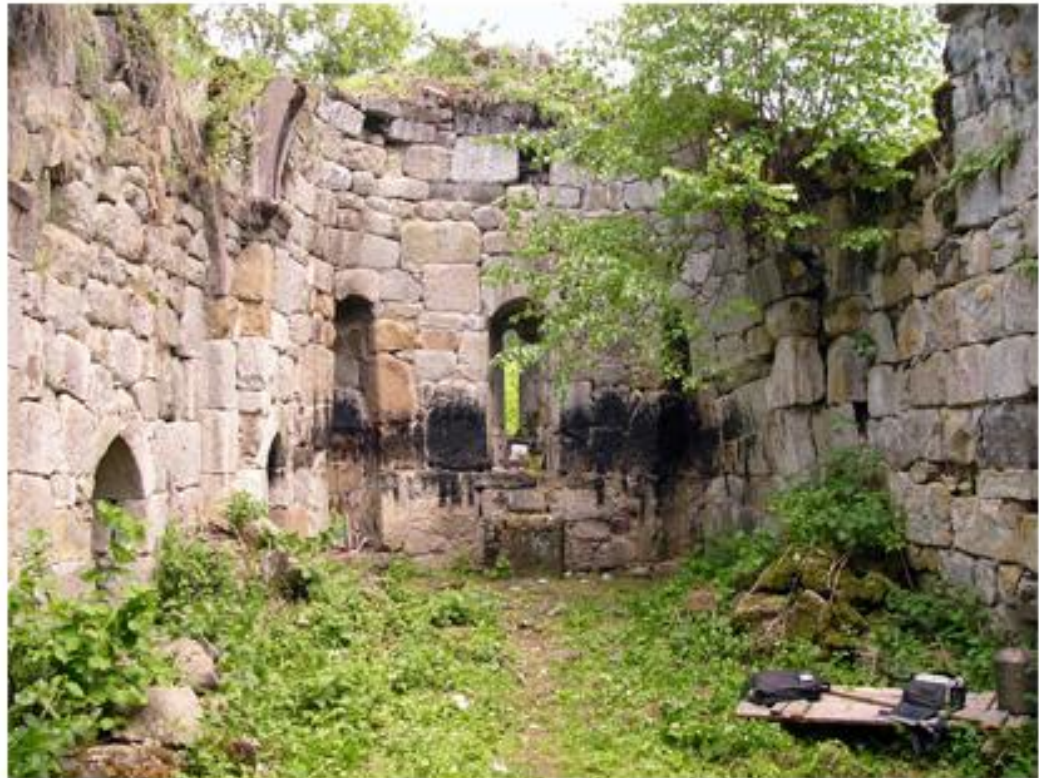
Interior, view to E

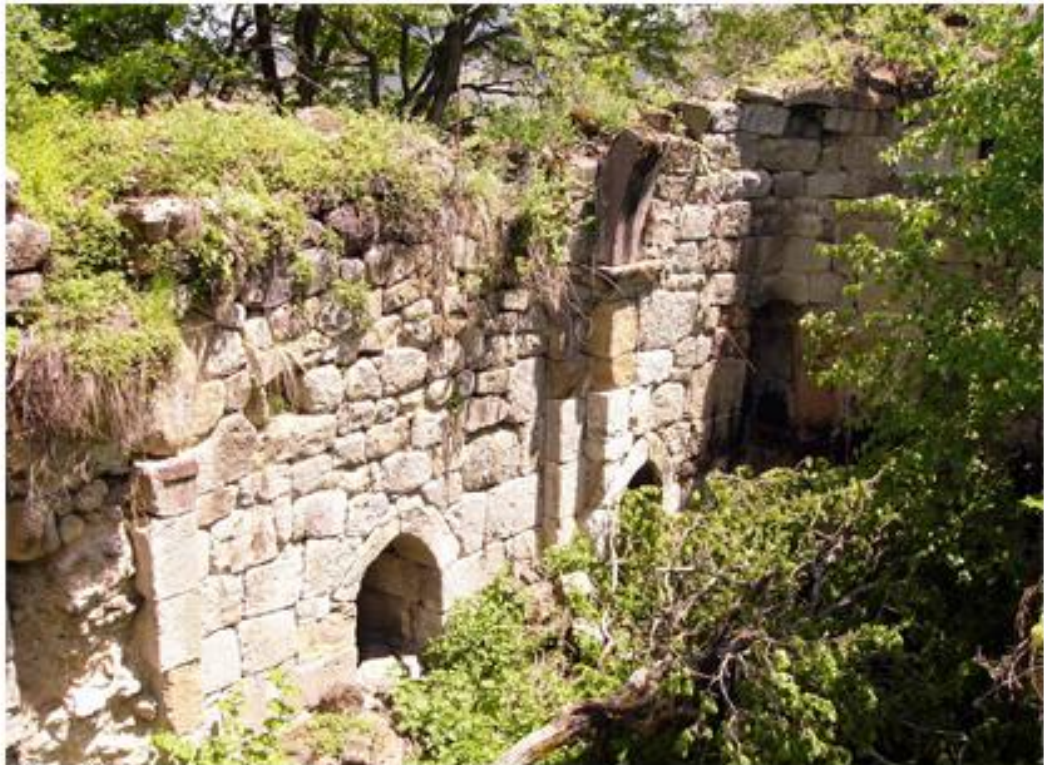
Interior, view to the N wall.

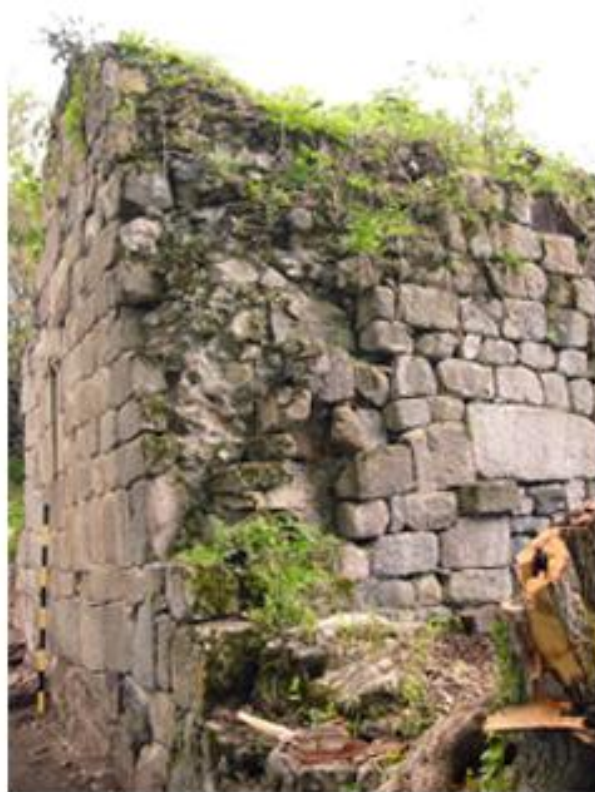
E fragment of the N facade

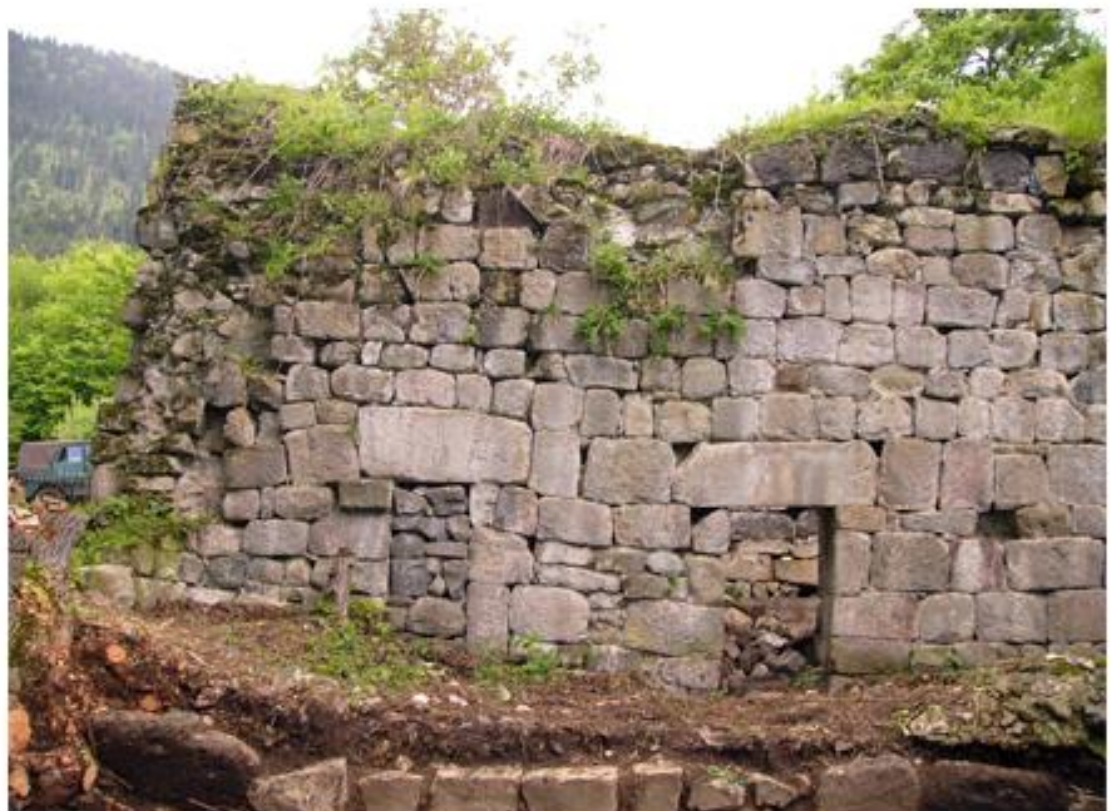
The fragment of th N facade.

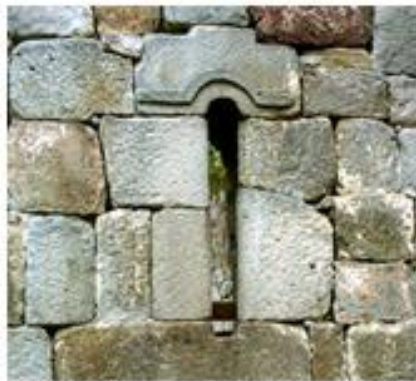
**Window of E facade**

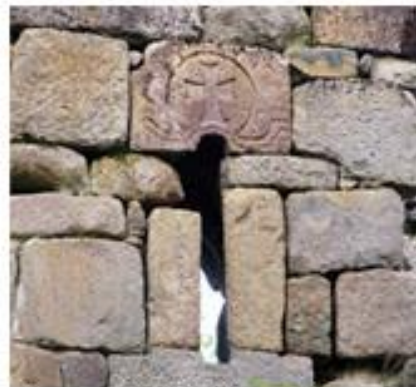
**Window of W facade**

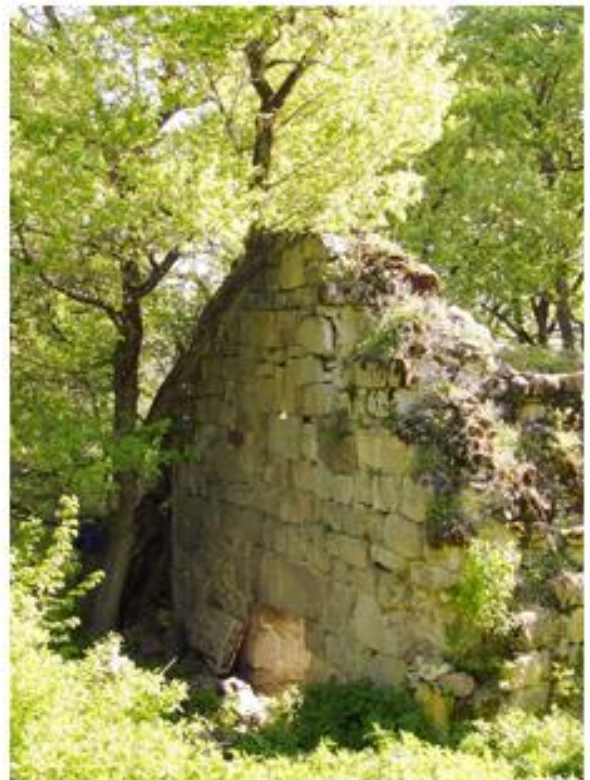
**View from W**
