**BAKU-TBILISI-CEYHAN CRUDE OIL PIPELINE PROJECT
ARCHAEOLOGICAL SALVAGE EXCAVATIONS PROJECT DOCUMENTS: 6**

DOĞU KİLİKYA'DA BİR ROMA HAMAMI

A ROMAN BATH IN EASTERN KILIKIA

MUHAMMET GÖRÜR

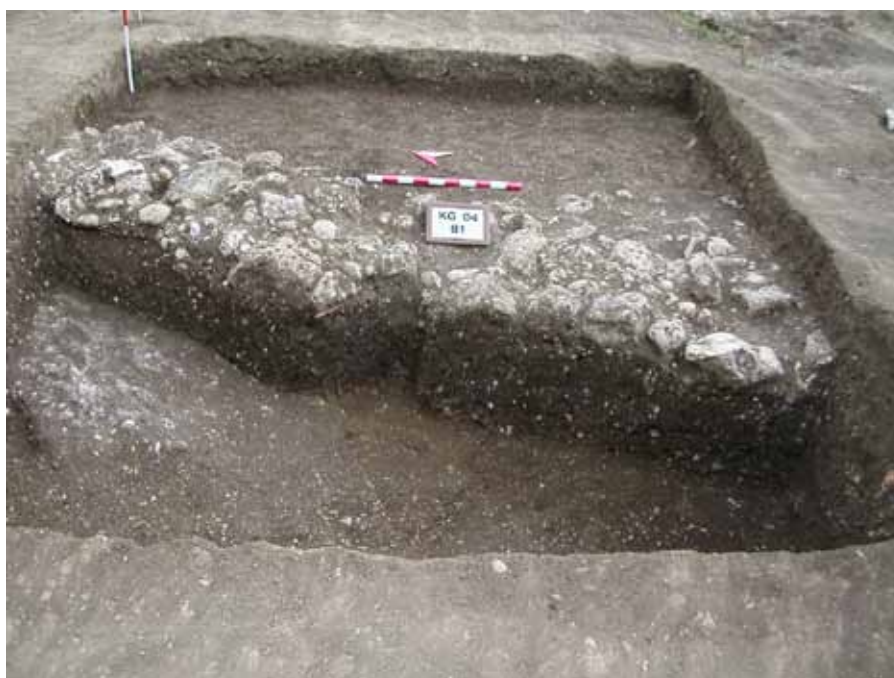
Figure 11: B1 trench.

When the debris stones were removed, a wall pertaining the late age starting from the south and progressing towards north, made of dry wall technique containing no attachment material, composed of double-row stones was revealed.

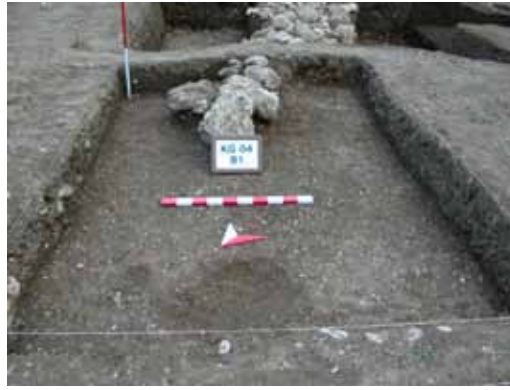
Figure 12: B1 trench.

In order to see the continuing part of the wall, works were continued in 1-5 / h-j plan-squares. Here the continuing part of the wall was revealed. It was seen that the stone order was ended up as it approached to the end.

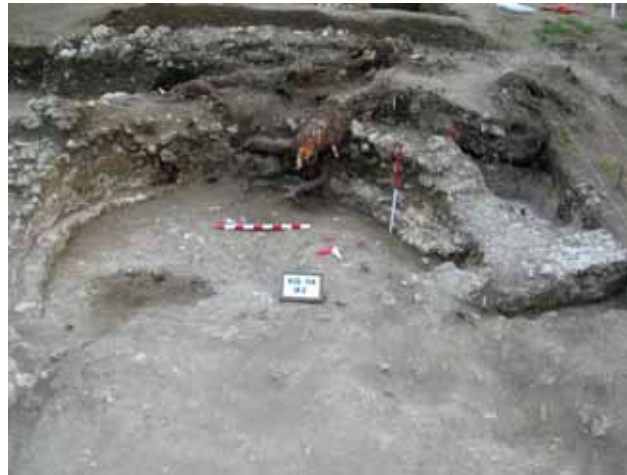
Figure 14: B2 trench.

In the works performed with the aim of identifying the wall, it was determined that the wall did not turn to east and south by creating a corner, rather by means of a curve. When the wall was completely revealed, it was found that the wall belonged to a residence with half-circular plan. (**Figure 14**)

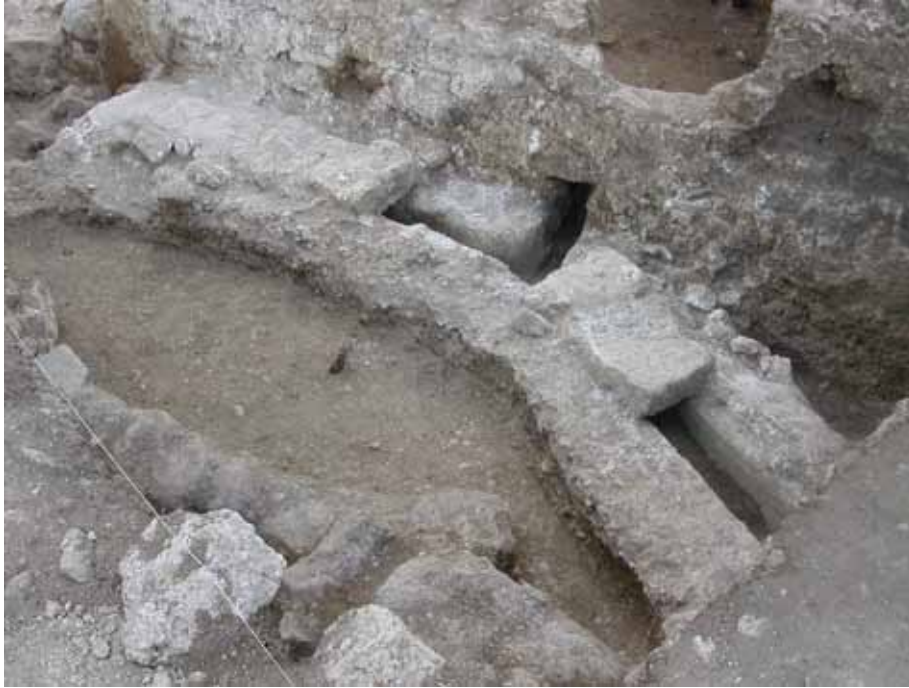
Figure 16: B2 trench.

Moreover, on the walls of the residence, a plaster with a thickness of 4 cm was used and a concrete with lime mortar was used on the ground. On the south of M5, a residence with rectangular plan was revealed on east – west direction. When the debris stones inside the residence were removed, a water duct originating from the east corner of M5 was seen, and it was covered with lid stones. **(Figure 16)** One end of the duct

faces west and the other faces east. The west end ends at the end of the residence. At the section where it ends, a smaller site northeast corner of which is curved and which has a smaller size catches the attention. This section is severely damaged. The end of the duct approaching to east passes to C3 trench from inside the wall. The width and height of the duct are 20 X 20 cm.

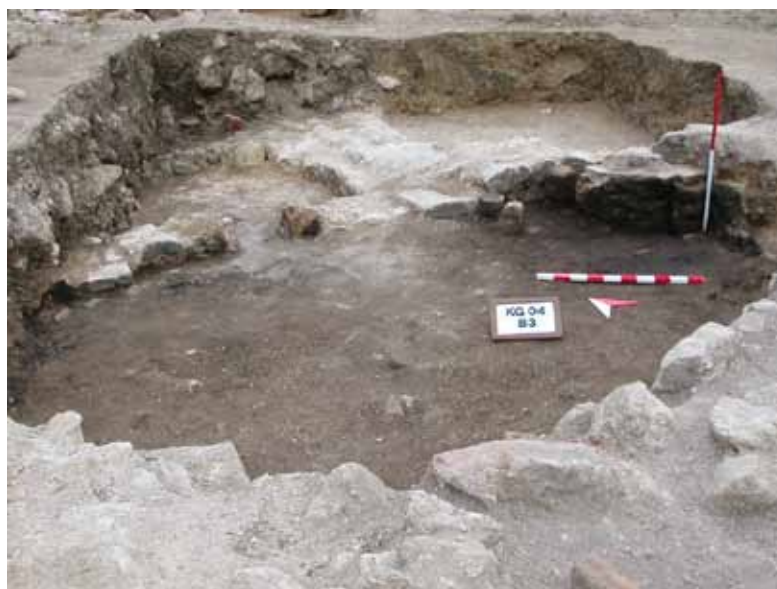
Figure 18: B3 trench.

On the west of this, there is the M9 site with dimensions of 500 x 350 m. overflowing the in the shape of exedra on northwest ad southeast.

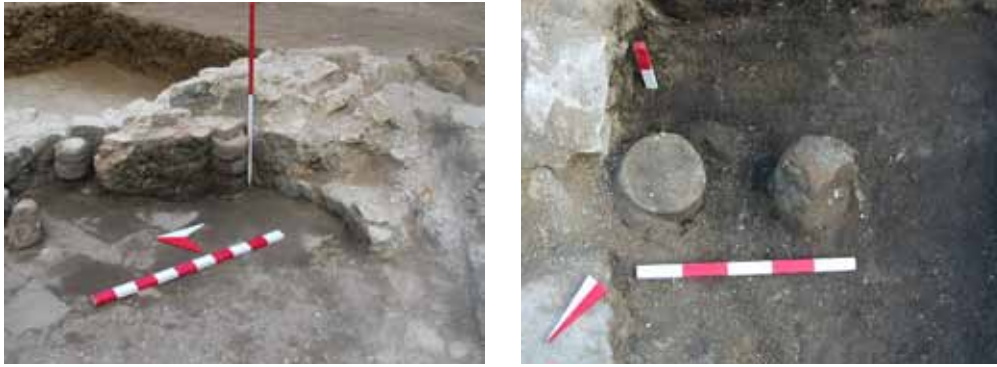
Figure 19: B3 trench.

Inside the exedra on the southeast corner of M8, on an area of 155x135 cm. hypocaust bricks in disc shape on the ground bricks at dimensions of 27 x 27 x 5 cm. as well as a broken ground brick on these (**Figure 19**) were obtained as in-situ. Similarly, in-situ hypocaust bricks were revealed in M6.

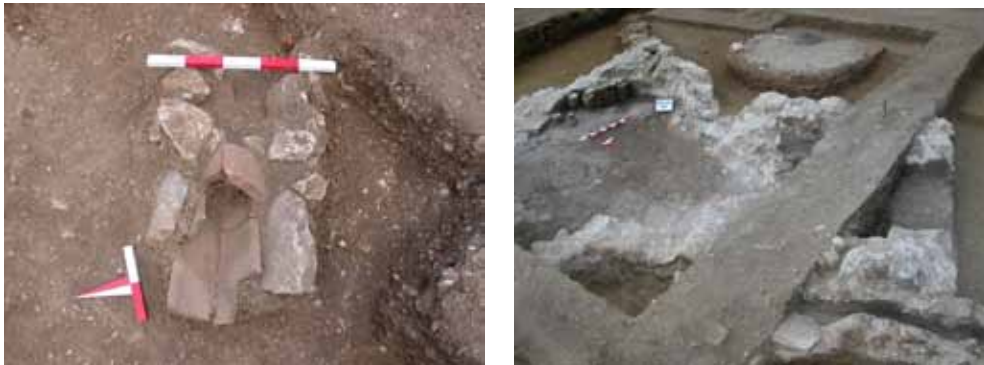
Figure 20: B3 trench.

On the west of M8, between D9 and D10, there is the M9 at dimensions of 215 x 190 cm., which bears soot and burns on its inner walls. On the approximate axis of the exedra on the southeast of M8, a pipe trace is found on the wall, and there is a water pipe next to this. **(Figure 20)** On the south of the pipe, a short duct made of lime plaster is ended with a lid stone. An arrangement starting from the south of the lid stone and, making a concave curve, reaching to C 4 trench, made of rubble stones placed without any plaster, which is thought to be a duct.

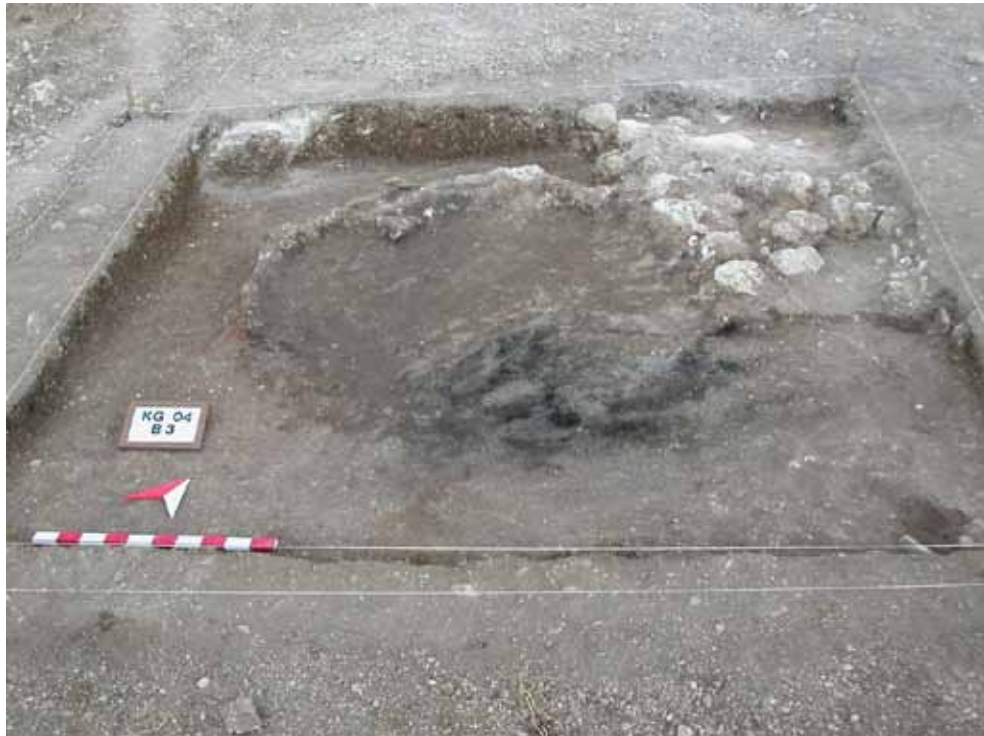
Figure 21: B3 trench.

On the south of M8 and M9, a section in half-circle shape made of single-row stones externally, with ground plastered with lime mortar is revealed, which is independent of the architecture. A very intense burnt layer is visible at the lower section of the ground.

On the walls in B3 trench, the regular hewn stones are used at the inner and outer section, rubble stones are put inside them, broken bricks and pebbles are used as filling materials, and lime mortar is used as the attaching material. Wall thickness vary between 65-80 cm.

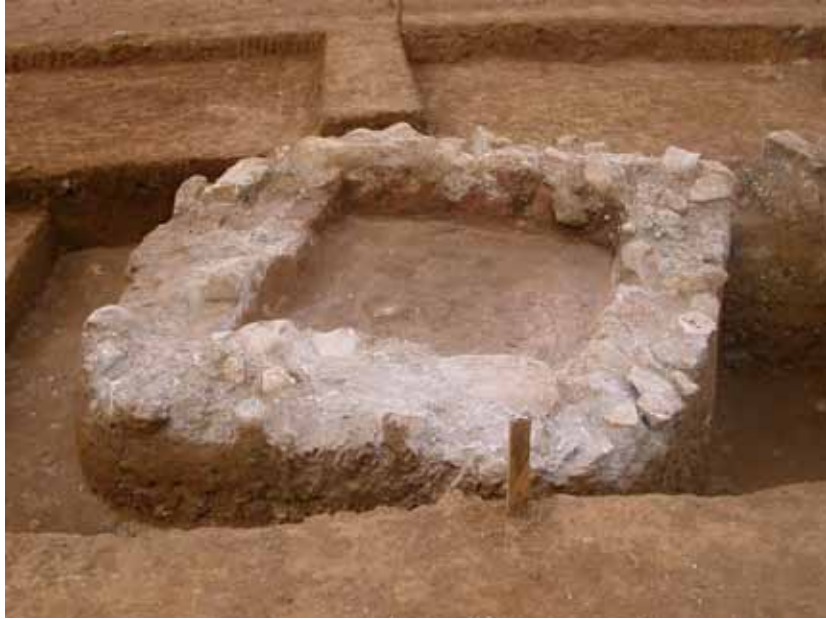
Figure 22: B 18 trench-detail.

In B18 trench, 9-10 / f-h plan-squares, a site which was protected, built with small sized stones, attached with lime mortar, with internal section plastered in reddish color was revealed, which had a “U” shape.

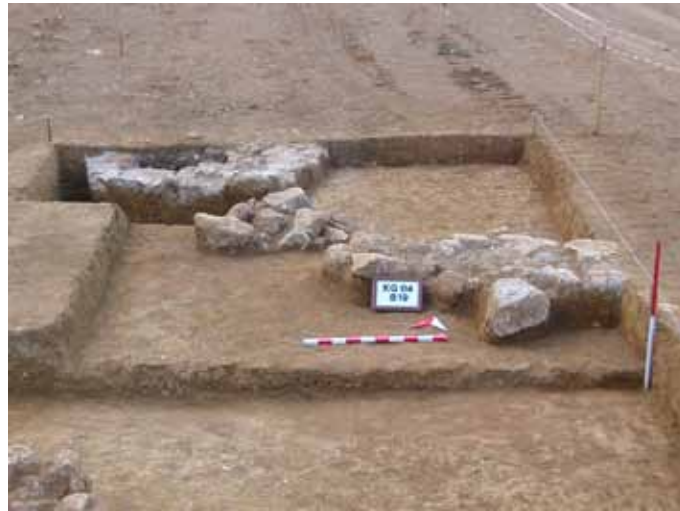
Figure 24: B19 trench.

During the works performed in B19 trench, 6-10/f-j plan-squares, a wall or a foundation composed of single row, progressing from east to west direction, turning to north approximately on the axis is revealed.

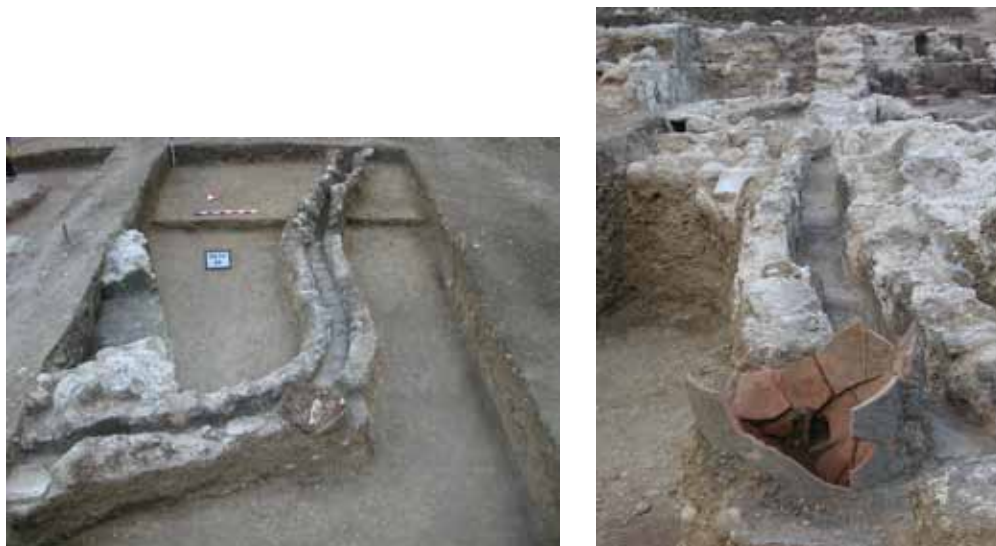
Figure 28: A 3 trench.

Adjacent to the north of D10 wall, a water duct with a width of 20 cm. and height of 20 cm made of regularly hewn stones was found, which was thought to be a water duct where the waste water was poured. (**Figure 28**)

The duct starts from the north of D10, and after progressing to the west, turns to south in a curved path, and ends on the southwest corner of the trench. At the corner which the duct turns, a pythos which is thought to be inserted in another period afterwards by breaking the duct, with mouth section broken, having a body of 57 cm was revealed. **(Figure 28)** Lime mortar was used as the attaching material between the stones in the duct. Besides, the inner section of the duct is plastered. The plaster has abundant lime, with small pebble stones and broken red brick. The part of the duct with hewn stone, mortar and plaster ends on the axle of D9 wall, and the part with rubble stone without any plaster and mortar remains. During the works, small amount of profiled and amorphous parts were found.

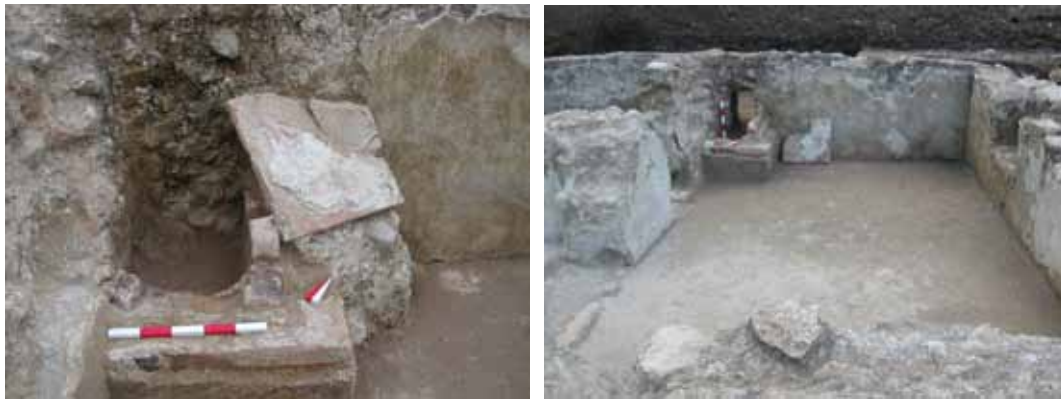
Figure 30: C 1 trench.

On the north of this ground, four hewn stone pedestals at dimensions of 40 x 50 x 20 cm symmetrically were revealed.

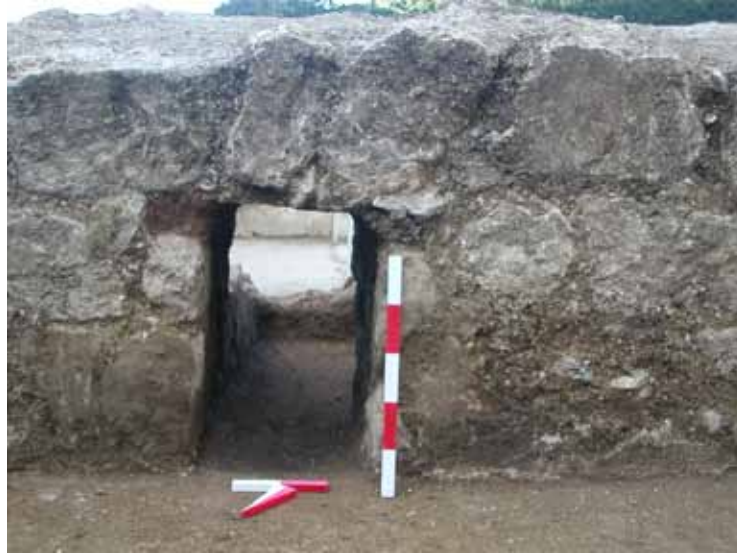
Figure 31: C 1 trench.

On the northwest corner of M3, there is an object with walls plastered, with dimensions of 100x76x62 cm. , and on its north, there is another object inside the wall, with dimensions of 40 x 60 cm, opening to outside through a gap, function of which could not be determined. **(Figure 31)** Again, on the east wall of the residence (D1), there are niches symmetrical to the axle, damaged, having a width of 85 cm, height of 52 cm and depth of 30 cm.

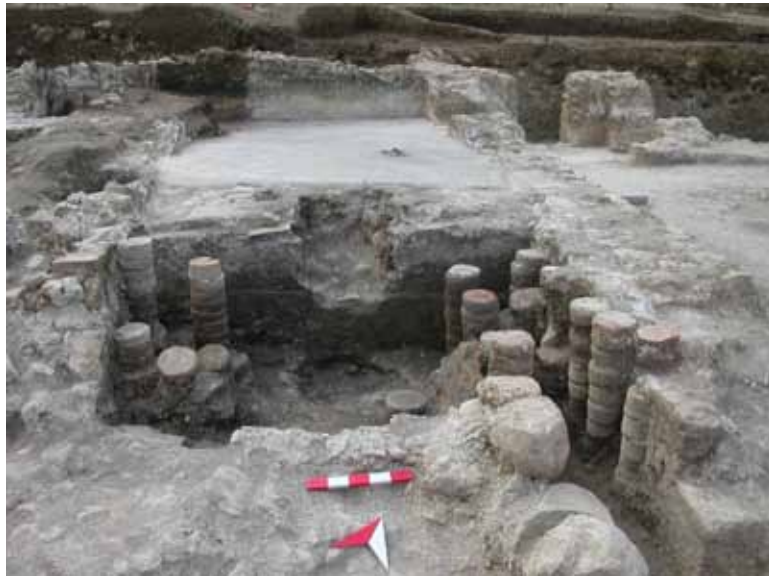
Figure 34: C 2 trench.

M2, M3 and M4 residences were created by the intersection D1, D2, D3 and D4. The thickness of the wall is 70 cm. Walls protected up to the height of approximately 1 m of plastered from inside and sutured from outside. On the south of M1, 1 m below the ground level, there is a residence which has 7 – 9 rows of hypocaust bricks. **(Figure 34)** Bricks have two types. The first is wide and flat and has a diameter of 22 cm and thickness of 7 cm, and the other has a bottom diameter of 18.5 cm and upper diameter of 16.5 cm, and a thickness of 8.5 cm. The duct coming from M1 from the lower part of the west wall of the residence progresses towards C 3 trench.

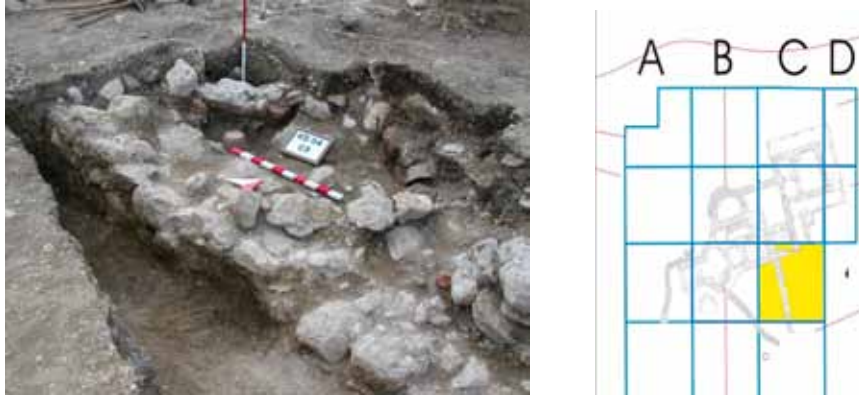
Figure 35: C 3 trench.

Works in C3 trench were initially performed on 1-3 /a-e plan-squares and D 9 trench was revealed. South section of the wall was roughly plastered. It is 30 cm thicker than other sections of the wall.

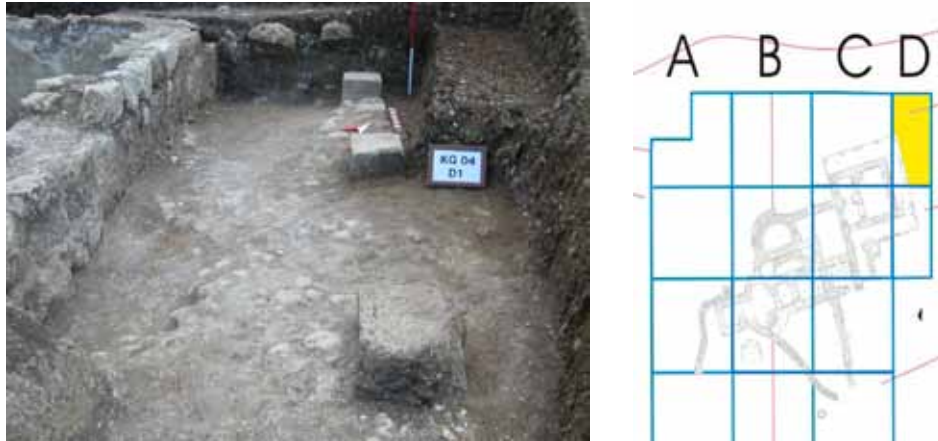
Figure 39: D1 trench.

D1 trench was opened with the aim of seen the continued parts of pedestals that were revealed on the corners of lime plastered revealed in C 1 trench. Works performed at 337.50-335.91 m. levels revealed a stone pedestal made of regular hewn stone located in intervals of around 2 m. While commencing the works in the trench, a copper coin pertaining to II. Constantinus was found on the surface. **(Figure 80: 2)**

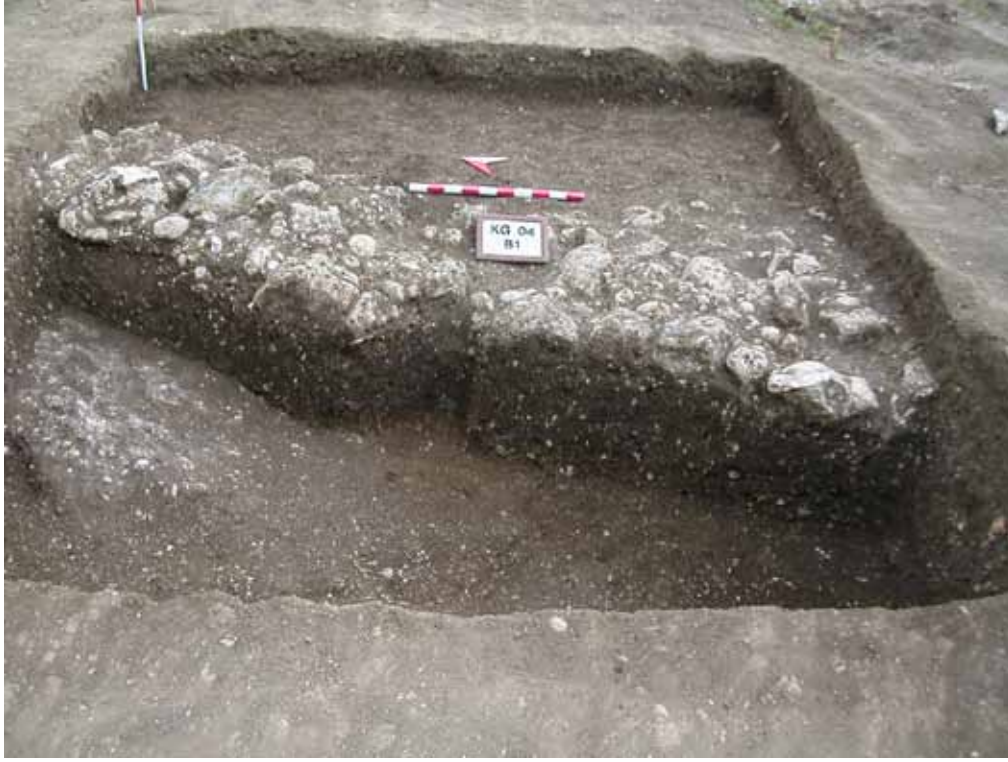
Figure 42 : B 1 trench.

In works commenced in B1 trench, when the debris stones were removed, a wall made of double row stones, where no attaching material was used, built with dry wall technique, starting from south and progressing towards north, pertaining to the last period was obtained. It was seen that the stone row was cut towards the end of the trench. **(Figure 42)**

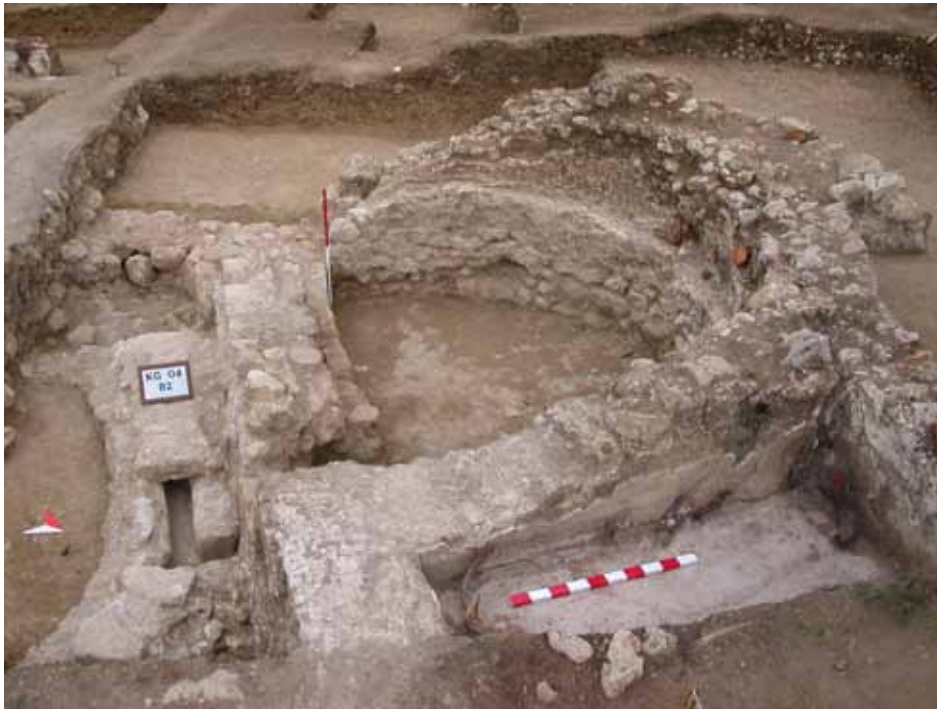
Figure 43 : B2 trench.

During the works in B2 trench, a wall with a length of 140 cm where lime mortar was used as the attaching material, which has bigger and more regular stones at the inner and outer surfaces, and where small rubble stones were used as filling material between them was found. In the works performed with the aim of identifying the wall, it was determined that the wall did not turn to east and south by creating a corner, rather by means of a curve. When the wall was completely revealed, it was found that the wall belonged to a residence with half-circular plan and its thickness was 70 cm. **(Figure 43)** It was seen that the thickness on the northwest of the residence was a supportive wall constructed afterwards with the aim of supporting the original wall.

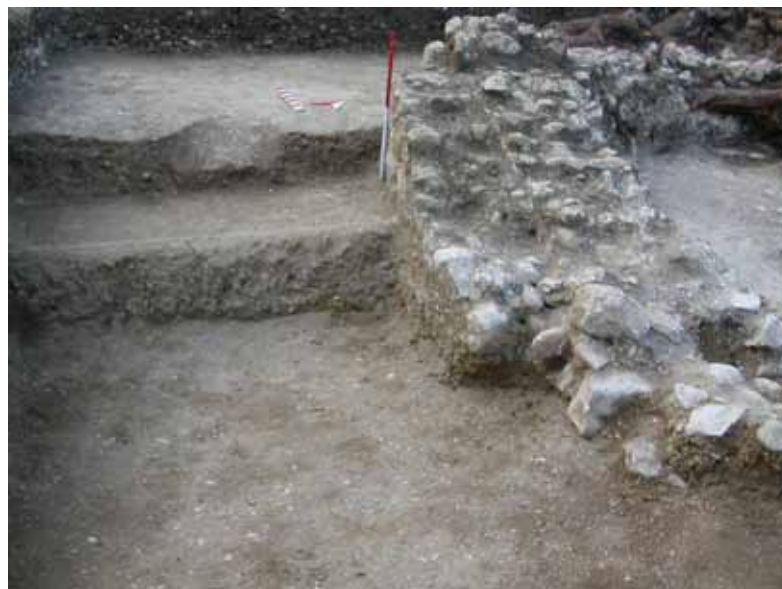
Figure 44 : Detailed view of B 2 trench.

Besides, the wall decreases by creating a grade of 50 cm. (**Figure 44**) at the inner section. It was seen that the grading circulated the site named M5.

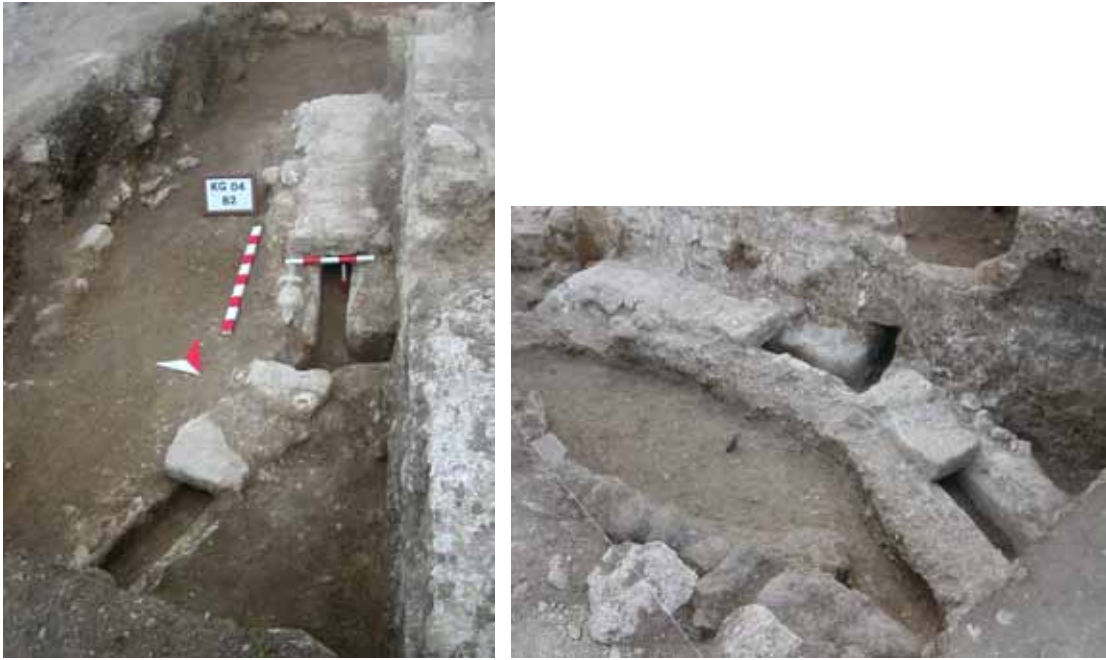
Figure 45 : Duct revealed in B 2 trench

material, and rubble stones was used as filling material between irregular hewn stones. Moreover, on the walls of the residence, a plaster with a thickness of 4 cm was used and a concrete with lime mortar was used on the ground. On the south of M5, a residence with rectangular plan was revealed on east – west direction. When the debris stones inside the residence were removed, a water duct originating from the east corner of M5 was seen, and it was covered with lid stones. **(Figure 45)**

One end of the duct faces west and the other faces east. **(Figure 45)** The west end ends at the end of the residence. At the section where it ends, a smaller site northeast corner of which is curved and which has a smaller size catches the attention. This section is severely damaged. The end of the duct approaching to east passes to C3 trench from inside the wall. The width and height of the duct are 20 cm each.

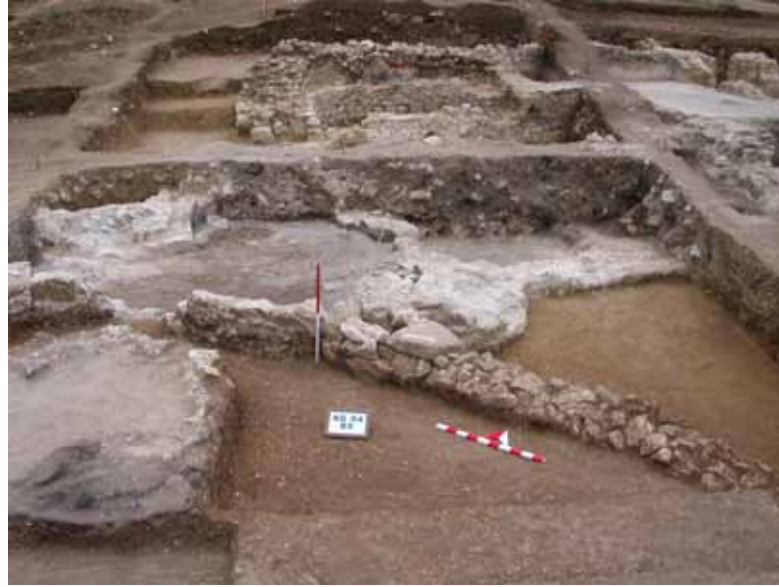
Figure 46 : B 3 trench.

When debris stones were revealed in B 3 trench, the site named M6 at dimensions of 250 x 190 cm by the intersection of D9, D10, D15 at certain intervals, and another site named M7 at dimensions of 163 x 273 m by the intersection of D9, D10, D15, D16 and D17 were revealed. On the west of this, there is the M9 site with dimensions of 500 x 350 m. overflowing the in the shape of half-circle on northwest ad southeast.

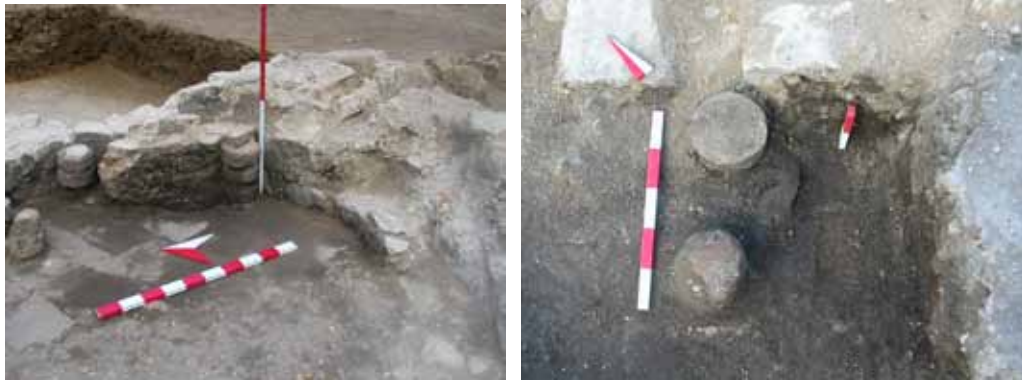
Figure 47 : B 3 trench hypocaust bricks- detailed.

Inside the half-circle on the southeast corner of M8, on an area of 155x135 cm. hypocaust bricks in disc shape on the ground bricks at dimensions of 27 x 27 x 5 cm. as well as a broken ground brick on these (**Figure 47**) were obtained as in-situ. Similarly, in-situ hypocaust bricks were revealed in M6.

On the south of M8 and M9, a section in half-circle shape made of single-row stones externally, with ground plastered with lime mortar is revealed, which is independent of the architecture. **(Figure 47)** A very intense burnt layer is visible at the lower section of the ground.

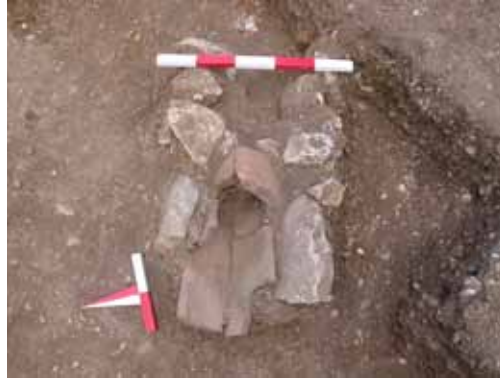
Figure 48 : B3 trench pipe remain

On the west of M8, between D9 and D10, there is the M9 at dimensions of 215 x 190 cm., which bears soot and burns on its inner walls. On the approximate axis of the exedra on the southeast of M8, a pipe trace is found on the wall, and there is a water pipe next to this. (**Figure 48**) On the south of the pipe, a short duct made of lime plaster is ended with a lid stone. An arrangement starting from the south of the lid stone and, making a concave curve, reaching to C 4 trench, made of rubble stones placed without any plaster, which is thought to be a duct.

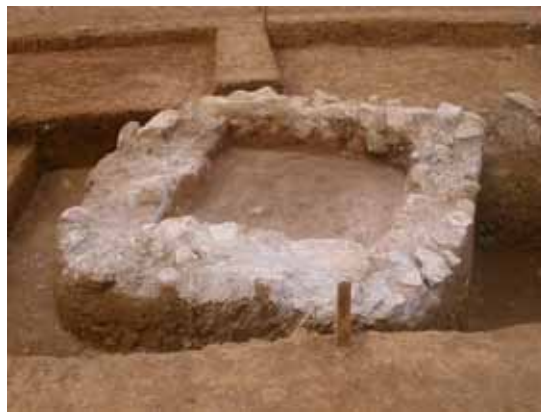
Figure 49 : B 18 trench.

In B18 trench, a site which was protected, built with small sized stones, attached with lime mortar, with internal section plastered in reddish color was revealed, which had a “U” shape. It is seen that the site continues towards B 19 trench.

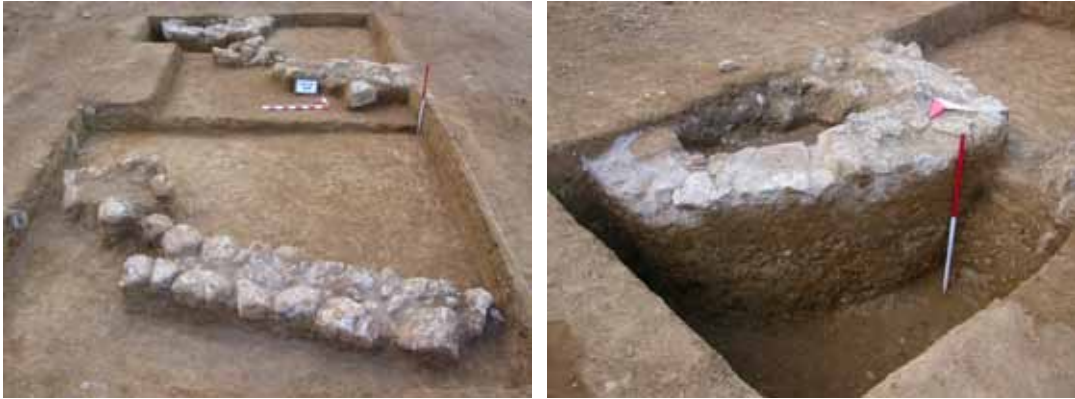
Figure 50 : B 19 trench.

During the works performed in B19 trench, 6a wall or a foundation composed of single row, progressing from east to west direction, turning to north approximately on

the axis is revealed. A “U” shaped small residence or establishment progressing towards B18 trench, with inner section plastered, with walls made of lime mortar was encountered.

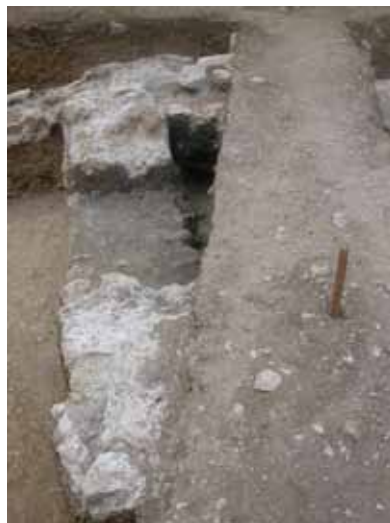
Figure 51 : A 3 trench.

Works in A3 trench were commenced by the drill performed in order to follow the D9 and D10 walls which started in B3 trench. In the drilling work, the D 9 wall having a wall thickness of 80 – 110 cm with a height of 70 cm. as well as the D 10 wall with a wall thickness between 92-110 cm. were found.

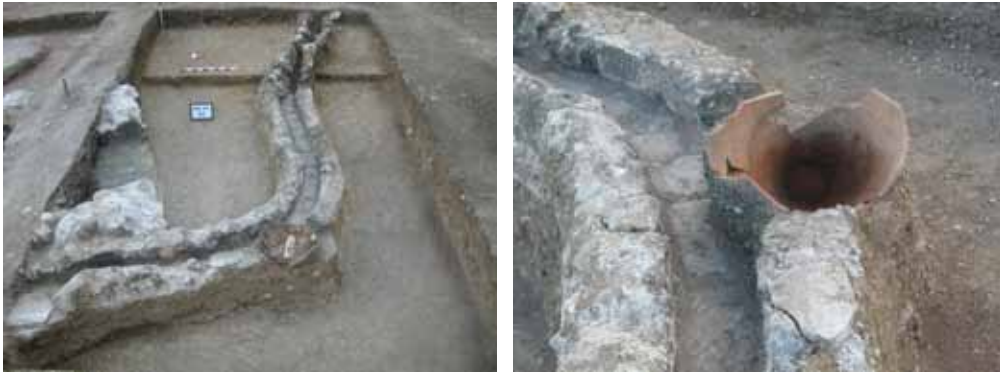
Figure 52 : A 3 trench duct and detail.

Adjacent to the north of D10 wall, a water duct with a width of 20 cm. and height of 20 cm made of regularly cut stones was found, which was thought to be a water duct where the waste water was poured. **(Figure 52)** The duct starts from the north of D10, and after progressing to the west, turns to south in a curved path, and ends on the southwest corner of the trench. At the corner which the duct turns, a pythos which is thought to be inserted in another period afterwards by breaking the duct, with mouth section broken, having a body of 57 cm was revealed. **(Figure 52)** Lime mortar was used as the attaching material between the stones in the duct. Besides, the inner section of the duct is plastered. The plaster has abundant lime, with small pebble stones and broken red brick. The part of the duct with cut stone, mortar and plaster ends on the axle of D9 wall, and the part with rubble stone without any plaster and mortar remains.

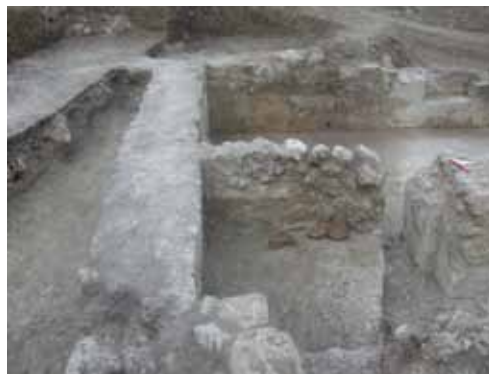
Figure 53 : C 1 trench.

Works in C1 trench were performed in order to determine the limits of the wall and residences revealed in C 2 trench. In 8-10/b-1 plan-squares, the D3 wall with a thickness of 75 cm with a length of 7.30 m was revealed on northeast – southwest direction. D3 wall is cut with D 1, D 11 and D 4 walls coming from C2 trench on northwest – southeast direction.

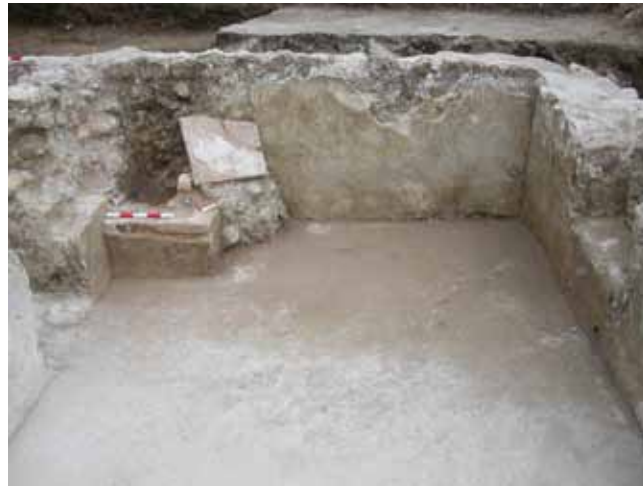
Figure 54 : C 1 trench.

The site between D1 and D11 walls was named as M3, and the site between D4 and D11 walls was named as M4. Height of the walls vary between 80-110 cm. The inner section and grounds of the residences are plastered. There is lime plastered ground on the north of residences. On the north of this ground, four cut stone pedestals at dimensions of 40 x 50 x 20 cm symmetrically were revealed. **(Figure 55)**

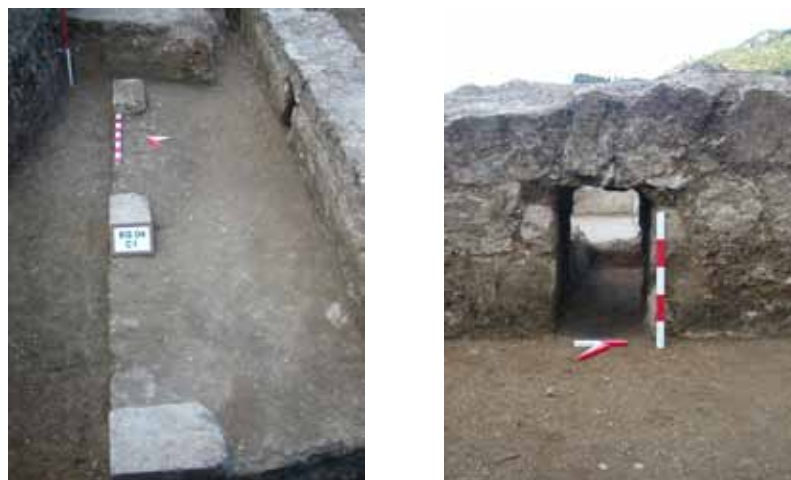
Figure 55 : C 1 trench.

On the northwest corner of M3, there is an object with walls plastered, with dimensions of 100x76x62 cm. , and on its north, there is another object inside the wall, with dimensions of 40 x 60 cm, opening to outside through a gap, function of which could not be determined. Again, on the east wall of the residence (D1), there are niches symmetrical to the axle, damaged, having a width of 85 cm, height of 52 cm and depth of 30 cm. **(Figure 55)**

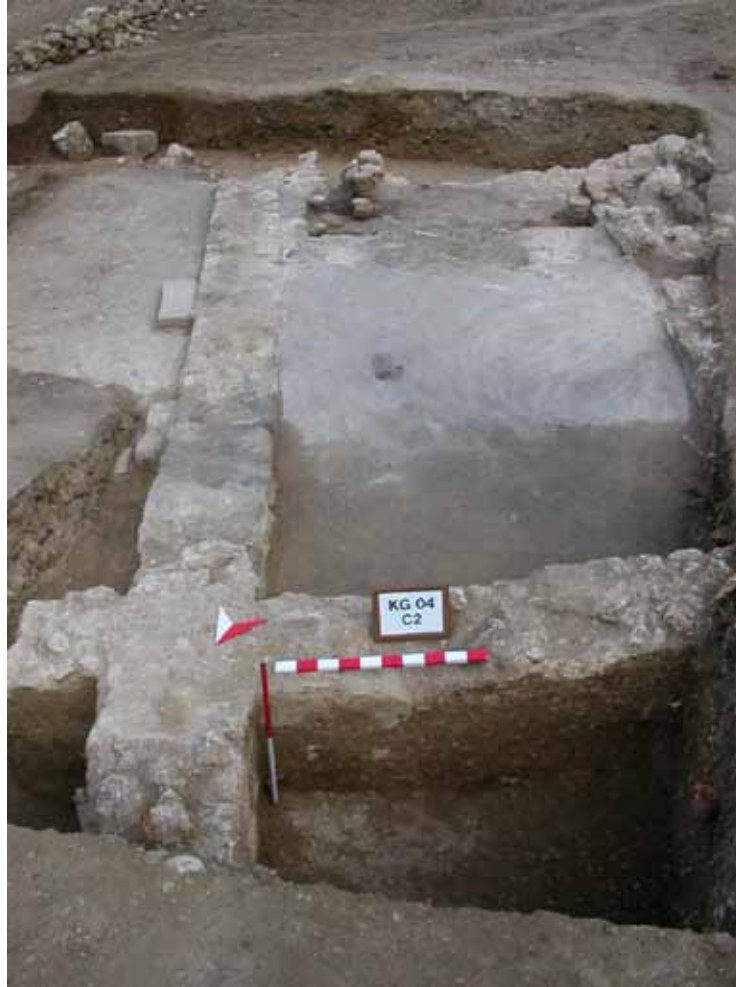
Figure 56 : C 2 trench architecture.

Four residences were revealed in C2 trench. The first residence is located on the north east corner of the trench. West of the “L” shaped residence is located in B2 trench. **(Figure 56)** The wall and ground of the residence is plastered. The plaster thickness varies between 3 – 4 cm.

The residence comprise of D4, D5, D6, D7 and D8 . There is a passage to M2 with a gap of 90 cm from D4. Then there is a passage to M3 and M4. M2, M3 and M4 residences were created by the intersection D1, D2, D3 and D4. The thickness of the wall is 70 cm. Walls protected up to the height of approximately 1 m of plastered from inside and sutured from outside. On the south of M1, 1 m below the ground level, there is a residence which has 7, 8, 9 rows of hypocaust bricks. **(Figure 57)** Bricks have two types. The first is wide and flat and has a diameter of 22 cm and thickness of 7 cm, and the other has a bottom diameter of 18.5 cm and upper diameter of 16.5 cm, and a thickness of 8.5 cm. The duct coming from M1 from the lower part of the west wall of the residence progresses towards C 3 trench

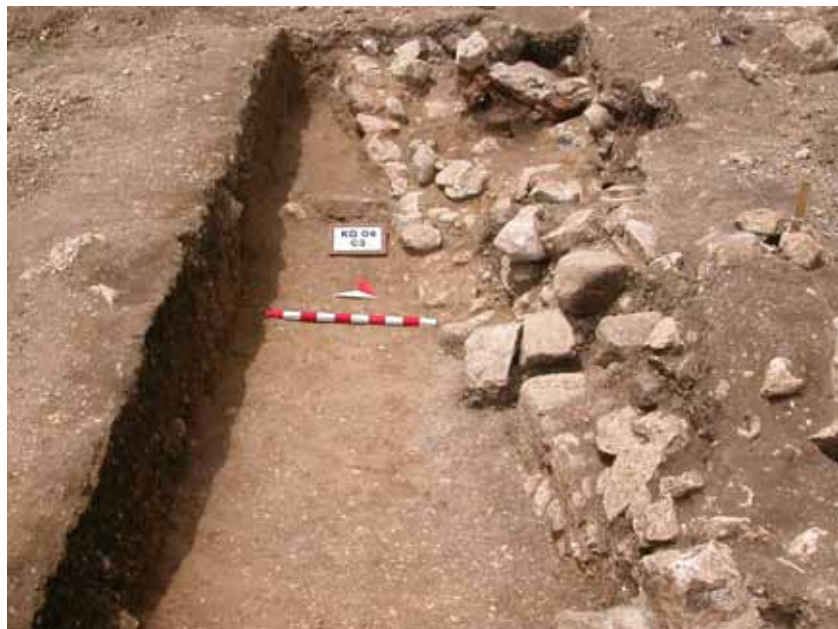
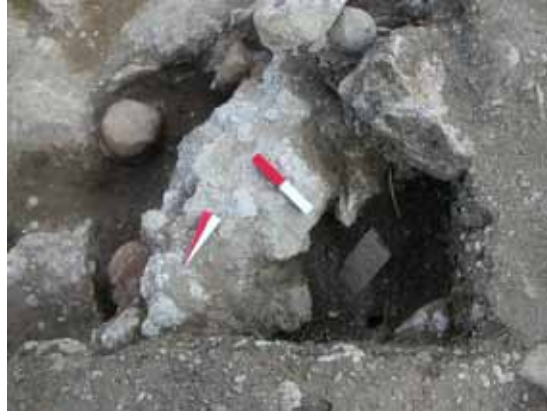
Figure 58 : C 3 trench .

During the works in C3 trench, D 9 trench was revealed. South section of the wall was roughly plastered. It is 30 cm thicker than other sections of the wall. The water duct exiting from B2 trench, passing through C 2 trench and under D 9 trench, continues in C 3 trench and arrives at C 4 trench. Upper section of the duct is coated with stones.

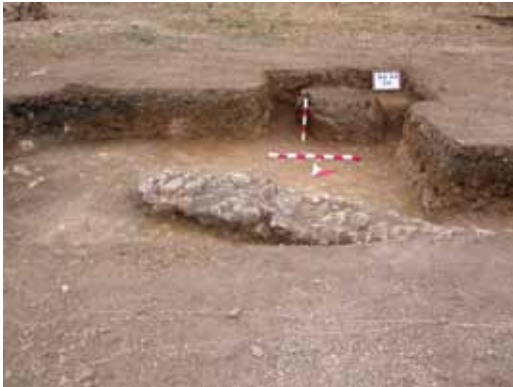
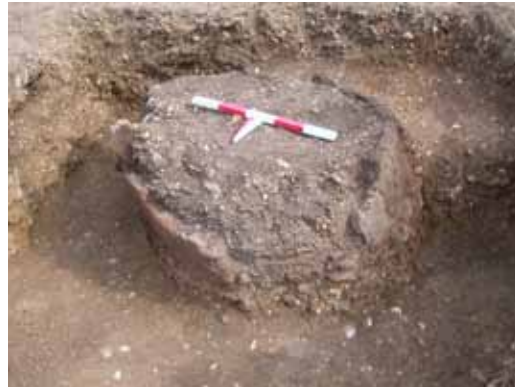
Figure 60 : C 4 trench.

Works in C4 trench were commenced with the aim to follow the water ducts that started in B3 trench and C 2 trench and arrived at C 4 trench and covered with non-plastered and irregular stones. A tandoor (hearth) was revealed on the southwest corner of the trench. (**Figure 60**)

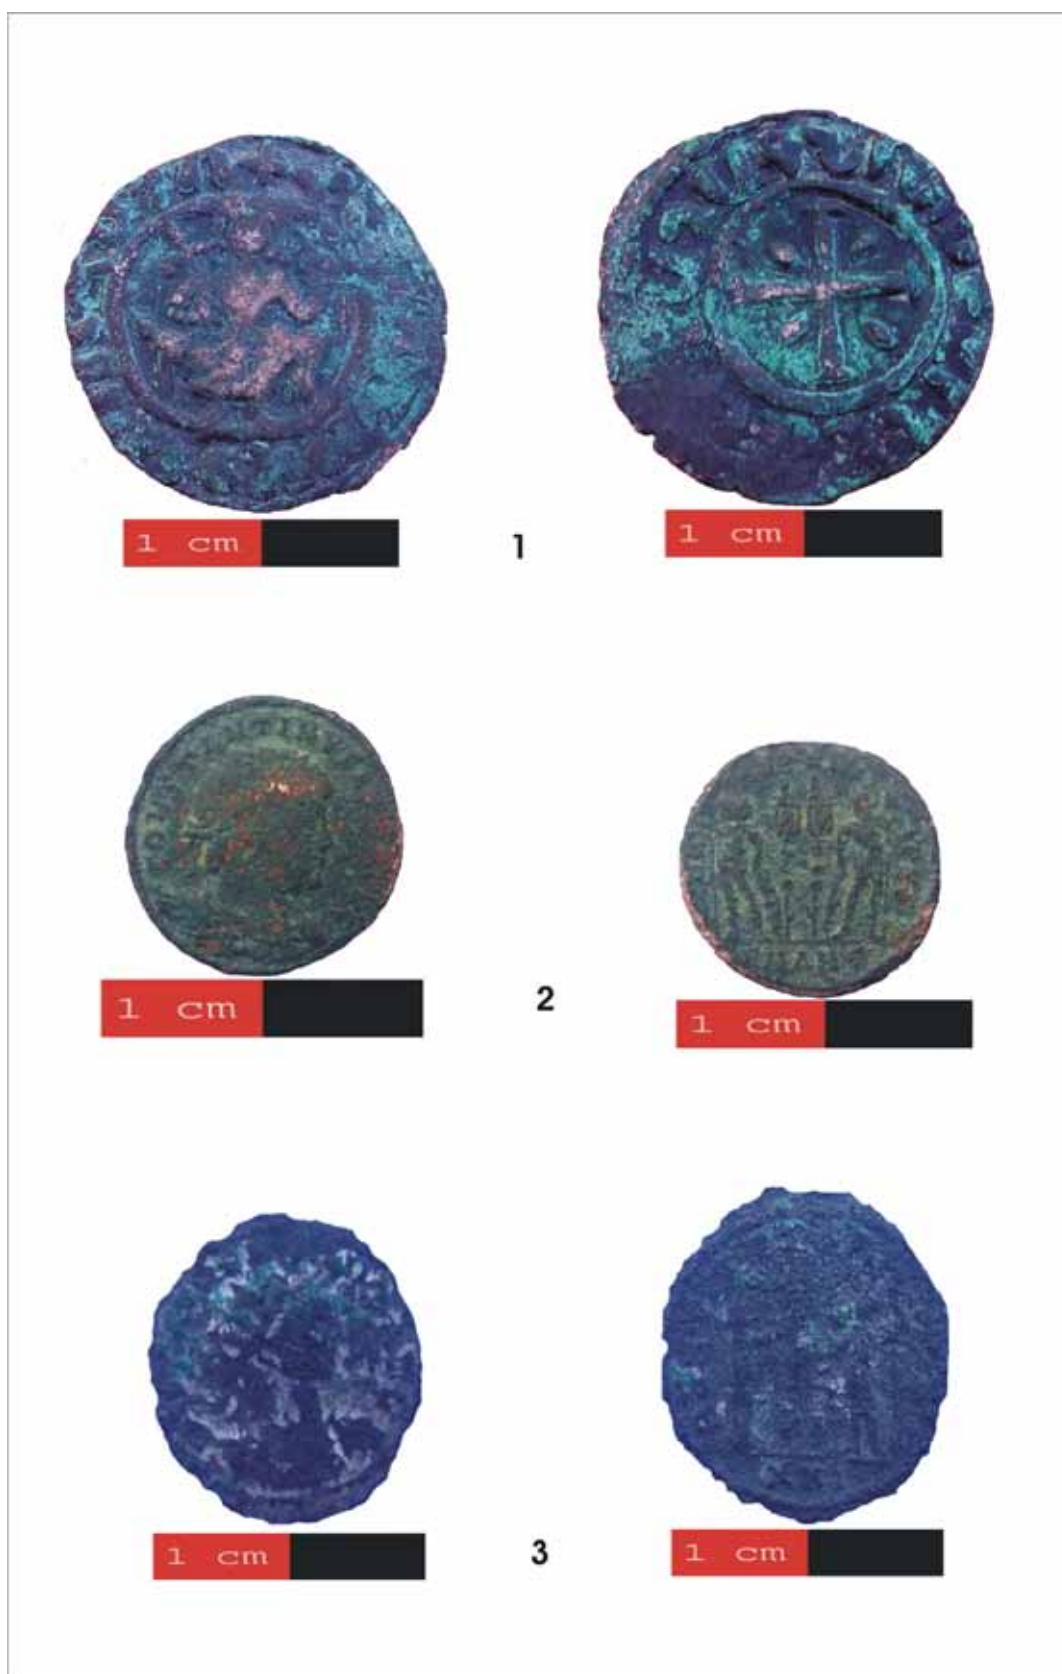
Res./ Fig.:80

During the works, a copper coin pertaining to Constantinus I.(297-306) which is exposed to strict corrosion was revealed in 1/d plan-square. **(Figure 80: 3)** Again, during the cleaning works performed in the tandoor (hearth) revealed on the southeast corner of the trench, a copper coin pertaining to Kilikya Armenian Prince I. Hetum (1226-1270) **(Figure 80: 1)** was found.

21 metal pieces were obtained in Kayranlık Gözü settlement. 2 coins obtained in C 4 trench, (**Figure 80-1,2**), 1 coin obtained from the surface (**Figure 80-3**), 16 nails and pegs found in various trenches and surface (**Figure 81-1,2,3/ 82-1,2,3,4/ 83-1,2,3,4/ 84-1**), and 1 iron ringlet are among the finds (**Figure 84-2**).
